SERVICE CONDITIONS AND WARRANTY GUIDELINES

AGRICULTURAL TRACK

Including Drive Wheels, Idlers, Midrollers

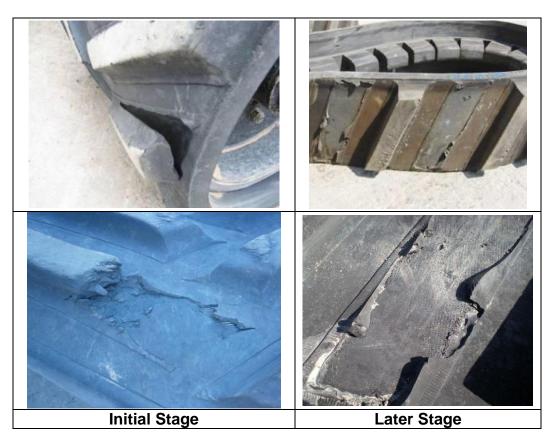
4.2.1 Smooth Base Separation

WARRANTY CAUSE: Poor adhesion due to contamination or improper cure

APPEARANCE: Failure is indicated by <u>smooth</u> surface at the tread bar to carcass interface, in some cases with jagged tears at the tread bar ends and outer edges

If a loose tread bar is noted for any reason (either from a defect or from non-smooth separation due to mechanical damage), make sure to trim any loose portion to minimize the chances of additional track damage if the loose tread bar is torn off.

Trimming may be done by putting the rubber in tension in the area you would like to cut. Then using a sharp knife, make small cuts and slowly cut through the smallest section in order to separate the loose piece.

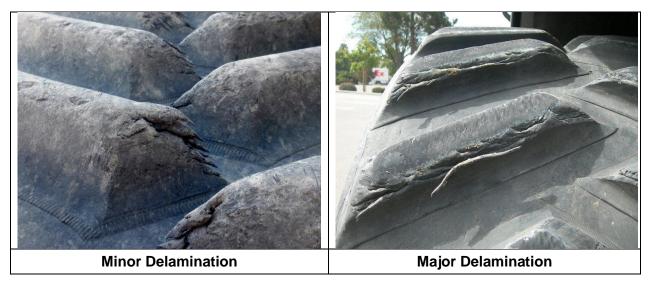
4.2.2 Delamination

WARRANTY CAUSE: Incomplete or improper cure, or contamination, poor source material.

APPEARANCE: This type of failure will usually be noted throughout all tread bars on the track, although it may be to differing degrees. The rubber material may separate in more than 1 layer as wear continues.

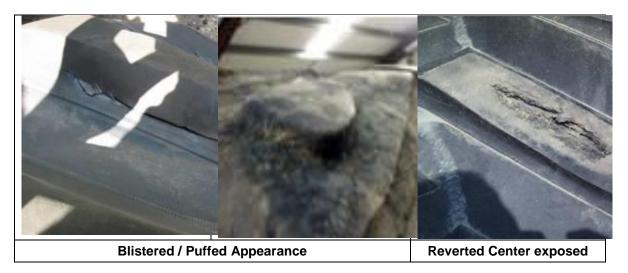
4.3.1 Internal Reversion/Blowout

NON-WARRANTY CAUSE: Excessive internal heat buildup caused by high loads combined with extended transport or roading.

APPEARANCE: Tread bar appears to blister and swells up. Eventually with further heat input it can split open. Inside appearance shows rubber which has been reverted into a soft, sticky consistency. Many times associated with failed midrollers as well.

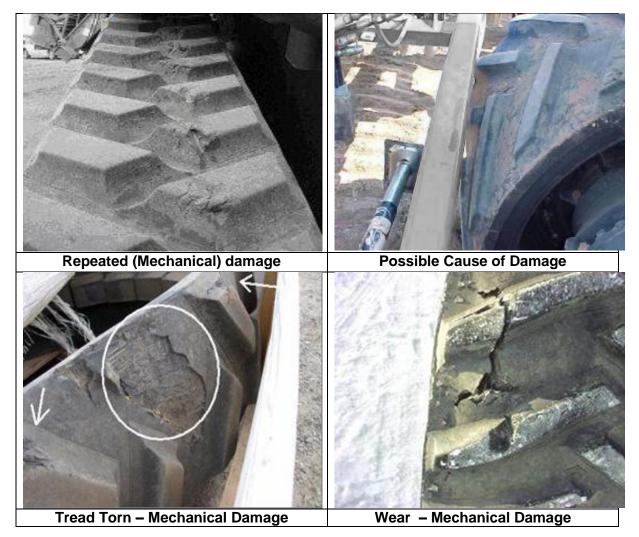
4.3.2 Mechanical Damage

NON-WARRANTY CAUSE: Mechanical damage

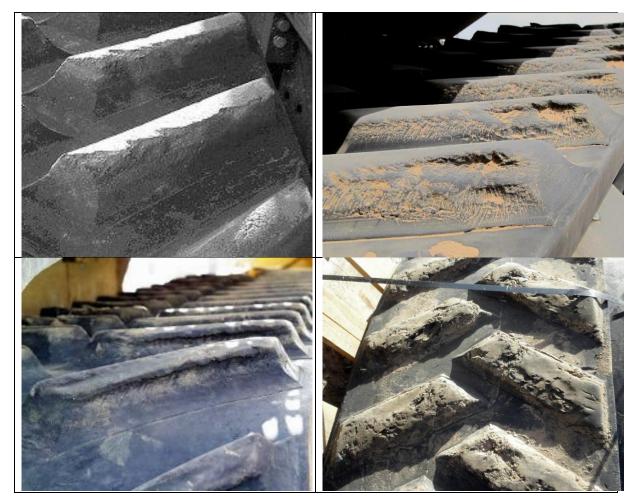
4.3.3 Abrasion, Erosion, or Chunking Damage

NON-WARRANTY CAUSE: Highly abrasive or hard/irregular soil conditions

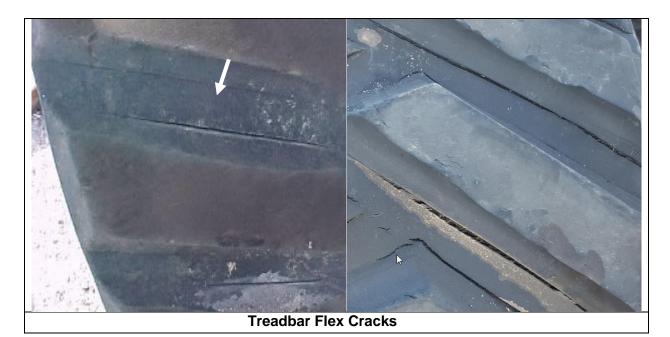
4.3.4 Flex / Base Cracks

NON-WARRANTY CAUSE: Flex cracking generally occurs over time, and is due to rubber fatigue. This fatigue is caused by repeated flexing and bending loads as the track goes around the wheels, and from tread bar stresses due to tractive effort.

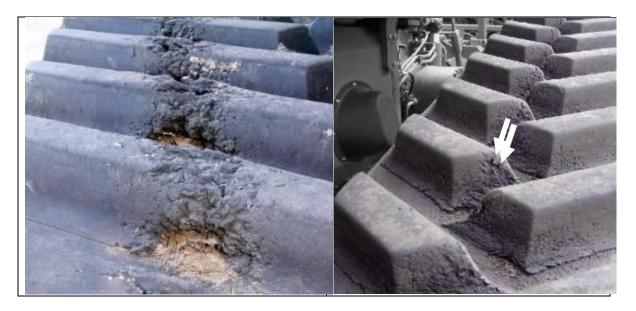
4.3.5 Stubble Wear

NON-WARRANTY CAUSE: Track operation with aggressive crop stubble in the same location on the track for an extended period of time.

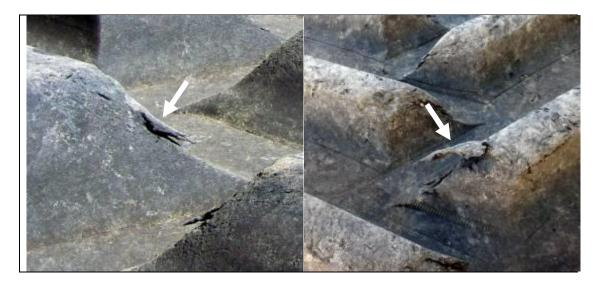
4.3.6 Inboard Edge Break-In Wear

NON-WARRANTY CAUSE: Operating in more aggressive or cloddy soil in high load / low ground penetration conditions, usually with new tracks

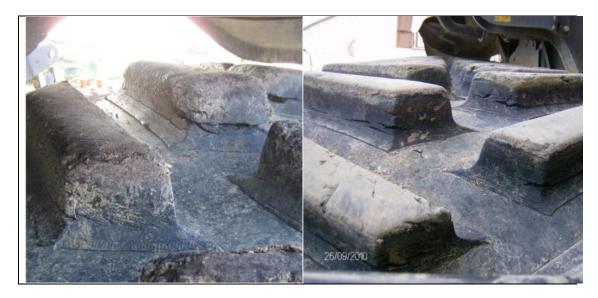
4.3.7 Tread Bar Fatigue Cracks

NON-WARRANTY CAUSE: Due to high drawbar loads in hard soil conditions with little to no tread bar ground penetration

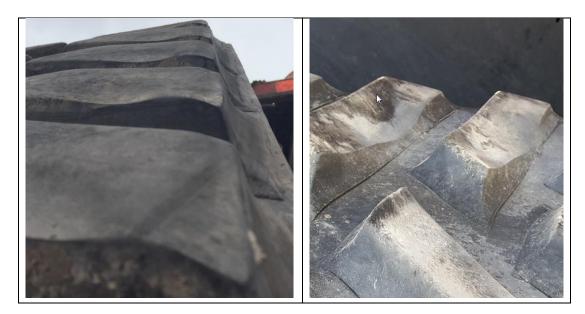
4.3.8 Tread Bar Cupping / Trailing Edge Wear

NON-WARRANTY CAUSE: Undercarriage wheels apply localized loading into the track wheelpath and into a portion of the tread bars. Other factors that can cause tread bar cupping are soil conditions, long distance or long duration roading at high speeds, additional tractor ballasting, and high axle loads.

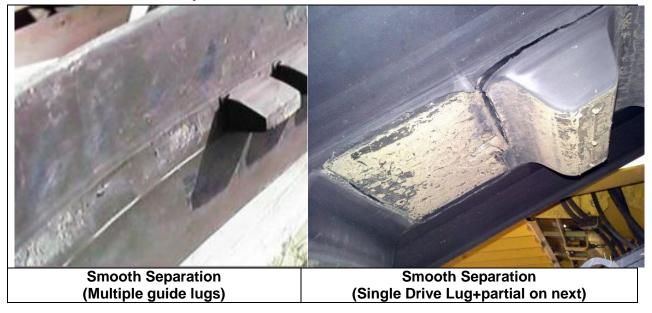
5.4.1 Smooth Base Separation

WARRANTY CAUSE: Poor manufacturing curing or contamination

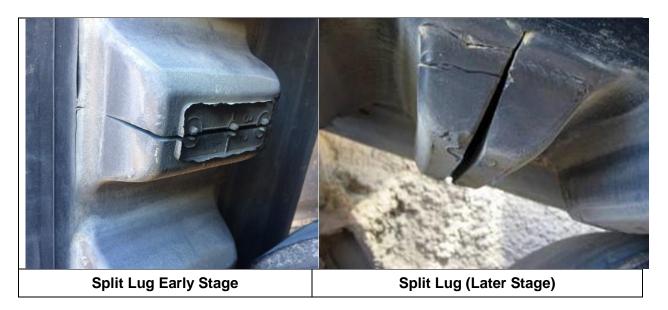
5.4.2 Drive Lug Loss (Split Lug)

WARRANTY CAUSE: Contamination or incomplete cure

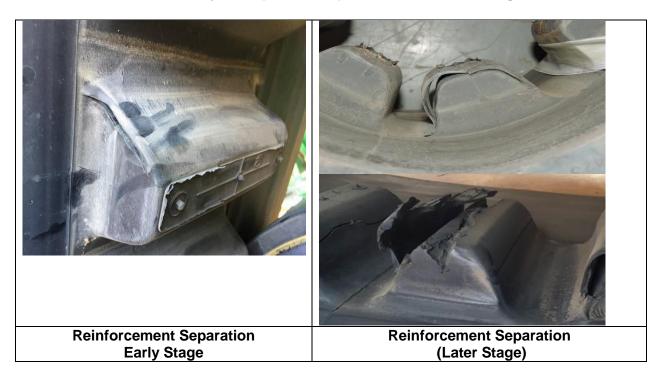
5.4.3 Reinforcement Layer Separation (Reinforced Drive Lugs)

WARRANTY CAUSE: Incomplete manufacturing cure or contamination.

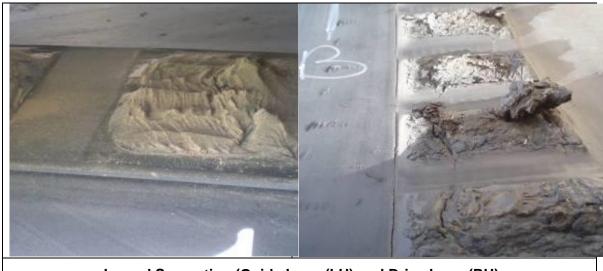
5.5.1 Torn or Jagged Separation

Jagged Separation (Guide Lugs (LH) and Drive Lugs (RH)

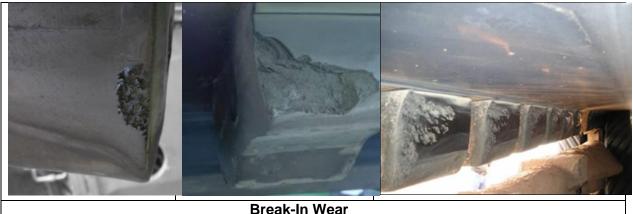
5.5.3 Break-In Wear (Lack of Dust or Wet Conditions)

NON-WARRANTY CAUSE: Rubber to rubber contact between guide lug and rolling components.

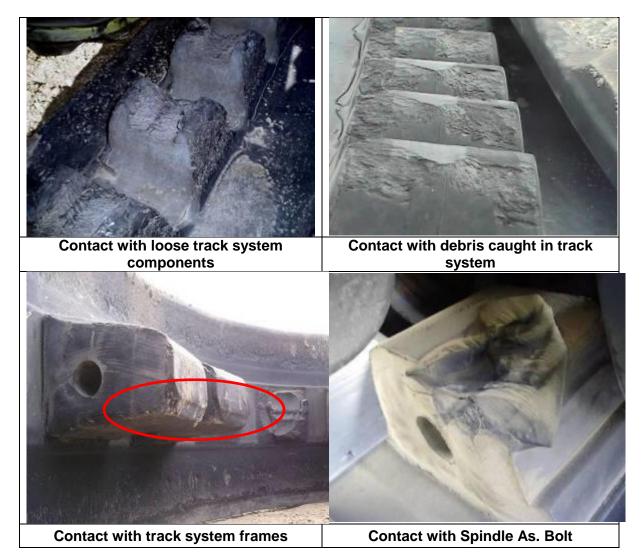
5.5.4 Repeated Tip Damage

NON-WARRANTY CAUSE: Loose bolts, failure of track drive or alignment components or mechanical damage to guiding lugs due to rocks and debris caught in the track system or between the wheels. This damage can also be caused by operating with excessively worn midrollers or midrollers with missing elastomeric coatings, or from uneven tread wear forcing guiding lugs up into the track system.

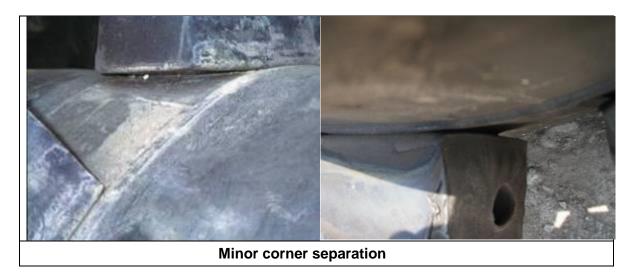
5.5.5 Corner Separation (Guide Lugs)

NON-WARRANTY CAUSE: Normal manufacturing edge relief and base fatigue due to long term operation.

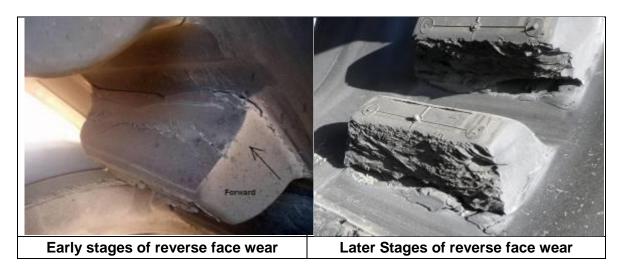
5.5.6 Reverse Face Wear (Drive Lugs)

NON-WARRANTY CAUSE(S): Mechanical damage from the drive bar scrubbing the reverse (non-power) side of the drive lug. Can be related to very low drawbar loading or extended amounts of roading. This can also be caused by incorrectly sized or worn drive wheels.

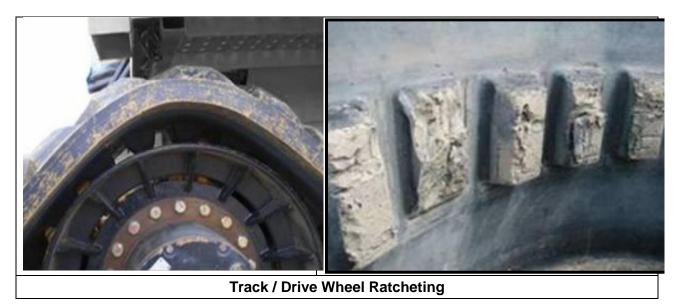
5.5.7 Ratcheting Damage (Drive Lugs)

NON-WARRANTY CAUSE: Mud Buildup on drive wheel. Low track tension. Severely worn drive lugs that become so narrow as to not be able to carry the torque loads.

APPEARANCE: The drive lugs are torn, usually with a jagged separation. Frequently if untracking has occurred more extensive mechanical damage including crushing or scuffing will be seen. A crushed drive lug will most likely be deformed and show internal fractures or splits. In some cases severe misalignment can cause side loads to fracture the drive lugs in a similar fashion or appearance.

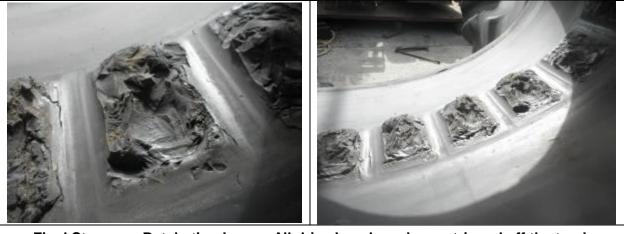
Final Stages or Ratcheting Loss – All drive lugs have been stripped off the track

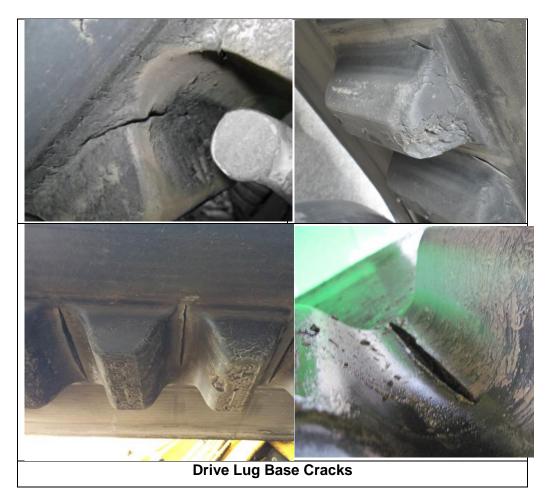
5.5.8 Base Cracks (Drive Lugs)

NON-WARRANTY CAUSE: Stress cracking due to side loads, misalignment, or ratcheting.

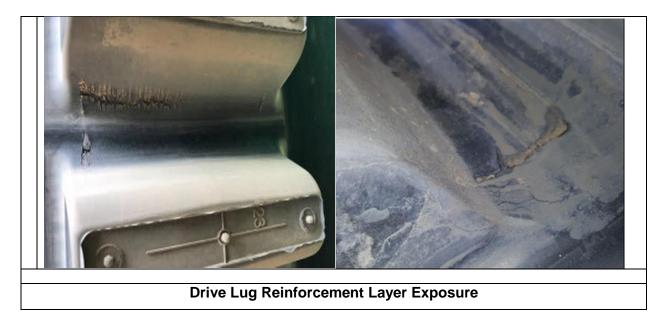
5.5.9 Reinforcement Layer Exposure (Drive Lugs)

NON-WARRANTY CAUSE: Abrasive soil conditions, improperly sized drive wheel, worn drive wheel, increased/modified power output of machine, sudden shock loading to the drive lugs (i.e. emergency braking or excessive track slippage followed by sudden traction).

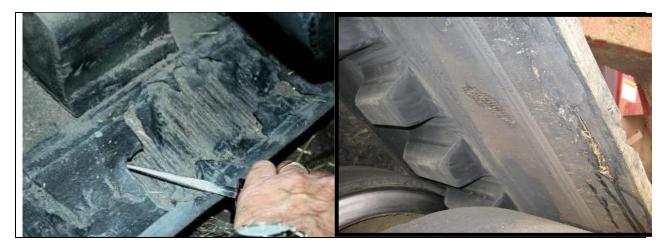
6.2.2 Carcass Separation (Localized Section)

WARRANTY CAUSE: Contamination or manufacturing cure.

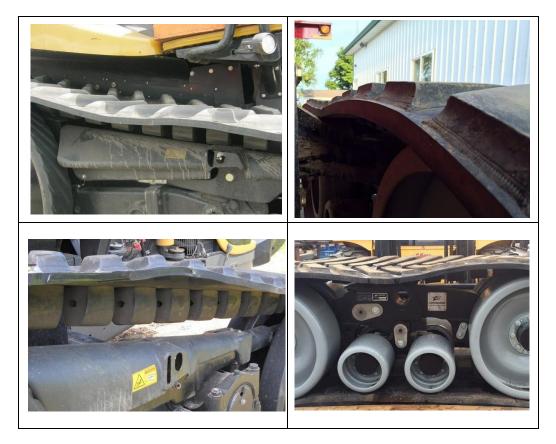
6.2.3 Distorted Carcass

WARRANTY CAUSE: Manufacturing issue

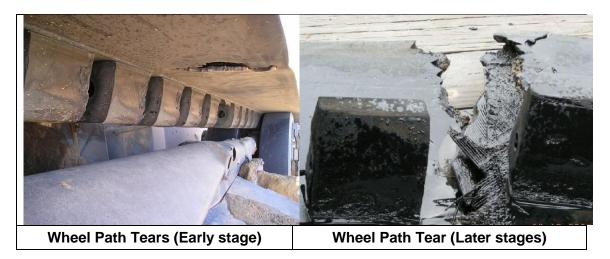
6.3.1 Main Cable Failure (Wheel Path Tear)

NON-WARRANTY CAUSE: Localized over tensioning of the main cable, due to:

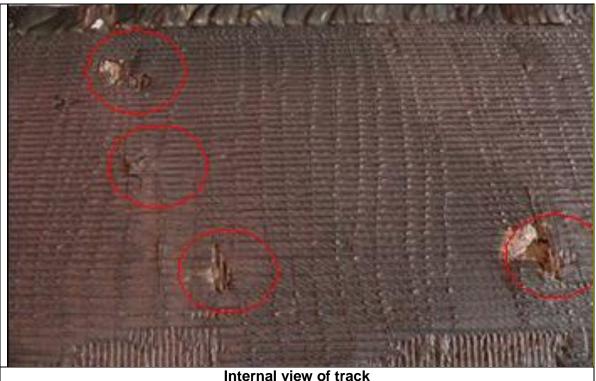
Pictures below show a track that has ran in the field with the inner rubber layer removed to expose the main cables. Several localized regions of the main cables have seen a puncture which has resulted in the main cables to be damaged and to begin to show signs of rust. Each of these locations is considered to be the beginning of a possible torn main cable.

Track main cable damage as a result of punctures to the inner surface of the track

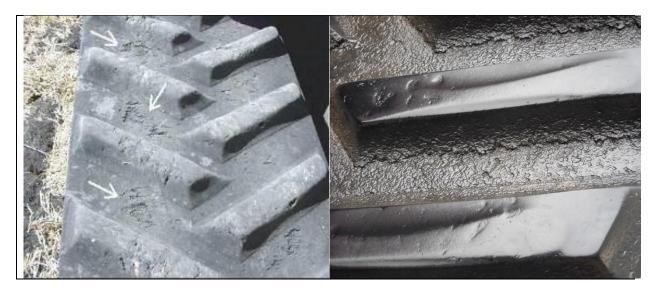
6.3.2 Stubble Wear or Abrasive Damage

NON-WARRANTY CAUSE: Track operation on sharp, woody crop stubble.

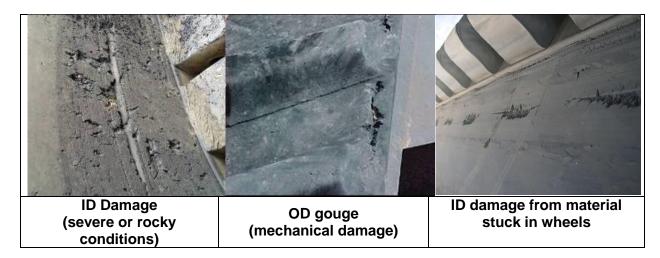
6.3.3 Internal or External Carcass Damage (Chunk, Cracks)

NON-WARRANTY CAUSE: Localized loading of carcass caused by:

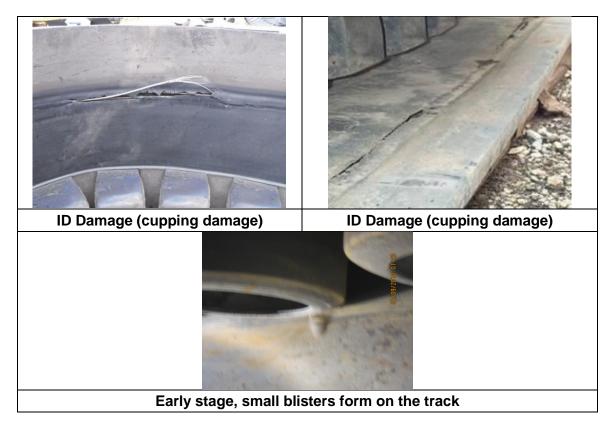
6.3.4 Internal Splits in the Carcass

NON-WARRANTY CAUSE: Localized loading of carcass caused by:

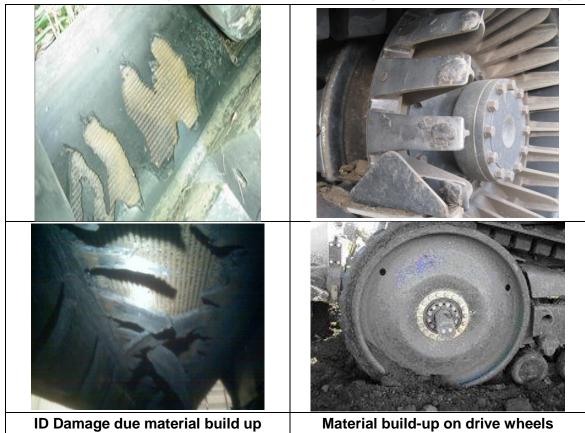
6.3.5 Wheel Path Separation—Friction Drive (Due to Material Buildup)

NON-WARRANTY CAUSE: Material building up on drive wheels, idlers, midrollers and/or operation with non-elastomeric coated wheels causing blistering or grooving of the inside track surface, overloading due to failed midrollers, excessive heat generation from extended transport time, or spinning of drive wheel inside the track.

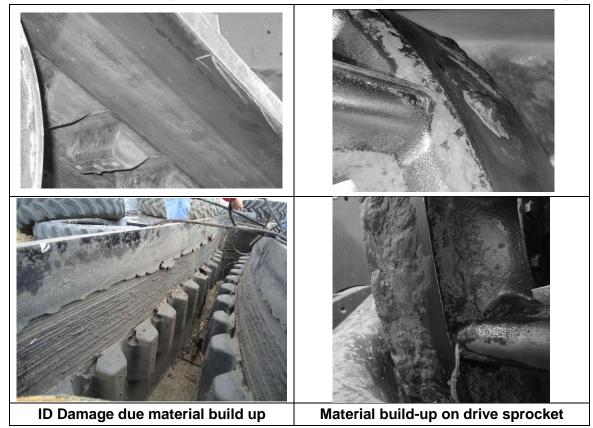
6.3.6 Wheel Path Separation—Positive Drive (Due to Material Buildup)

NON-WARRANTY CAUSE: Material building up on drive wheels, idlers, midrollers and/or operation with non-elastomeric coated wheels causing blistering or grooving of the inside track surface, overloading due to failed midrollers, excessive heat generation from extended transport time, or spinning of drive wheel inside the track.

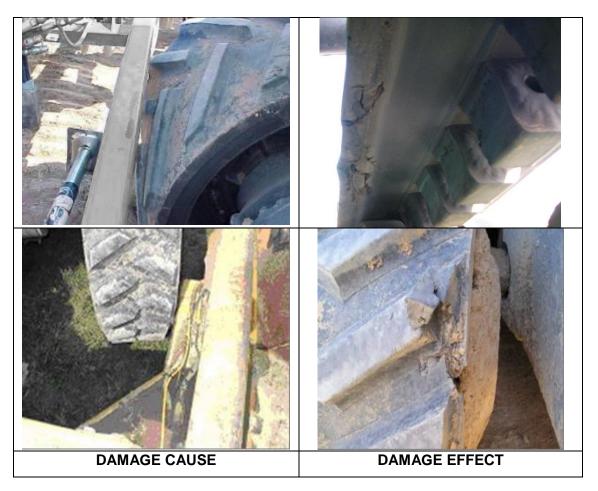
6.3.7 Mechanical Edge Damage

NON-WARRANTY CAUSE: Mechanical contact with external objects such as an implement, posts, blades, posts, culverts, machine frame, etc.

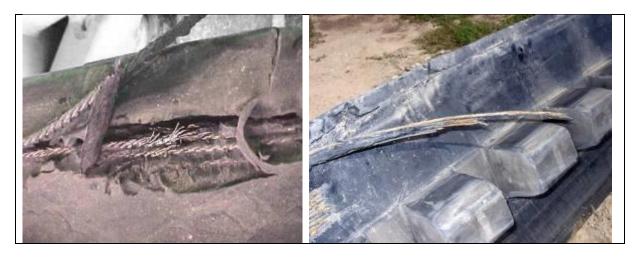
6.3.8 Exposed or Loose Main Cable

NON-WARRANTY CAUSE: Inside rubber cracks or splits, or mechanical damage, causing exposed cable.

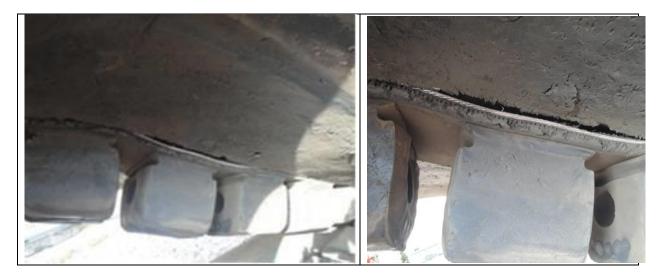
6.3.9 Carcass Ribbon Separation

NON-WARRANTY CAUSE: Hard material buildup on drive wheels or idler wheels. Operation with drive lugs without full track width support on the drive wheel. <u>Frequently this failure mode is a secondary failure as a result of a main cable / wheelpath tear.</u>

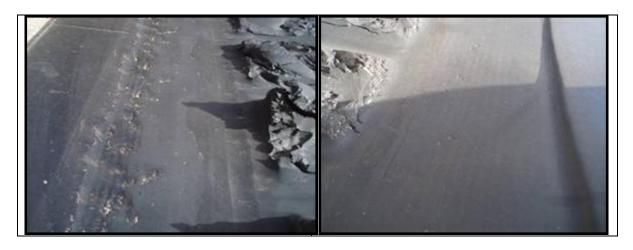
6.3.10 Wheel Path Wear (Internal surface)

NON-WARRANTY CAUSE: Normal wear. In some severe cases, drive wheel to track slippage, due to loss of tension and resulting in drive lug ratcheting, material buildup on drive wheel, or lockup of midroller inside the track.

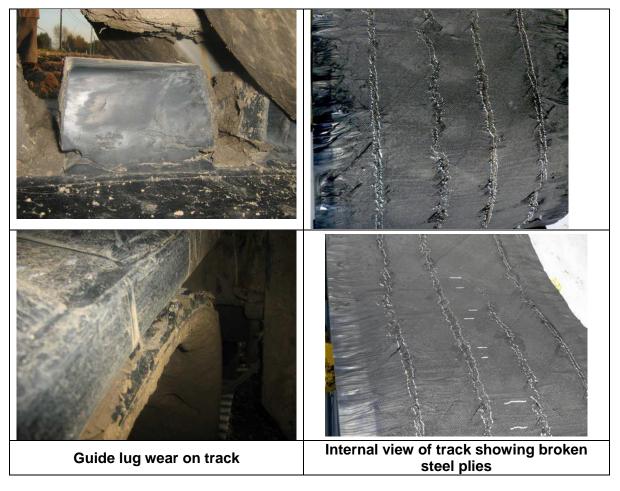
6.3.11 Loss of alignment

NON-WARRANTY CAUSE: Broken steel plies within the carcass of the track.

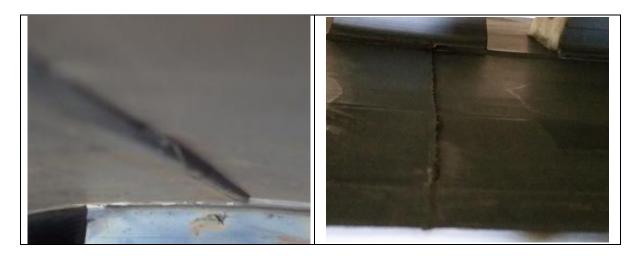
6.3.12 Track Noise (Snapping or clicking)

NON-WARRANTY CAUSE: Normal rubber flash from track assembly process

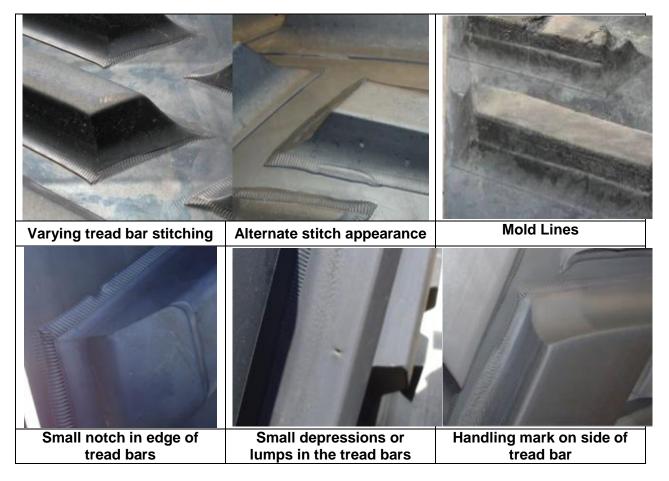
7.1 Tread bar

NON-WARRANTY CAUSE: Normal manufacturing process-due to minor manufacturing defects, environment or minor mechanical damage.

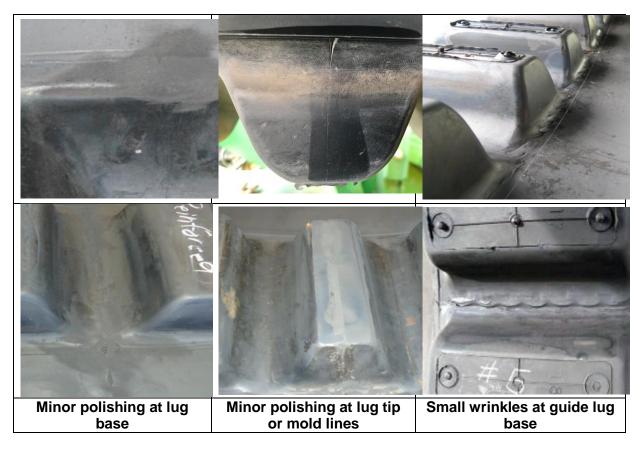
7.2 Drive Lug

NON-WARRANTY CAUSE: Normal manufacturing process-due to minor manufacturing defects, environment or minor mechanical damage.

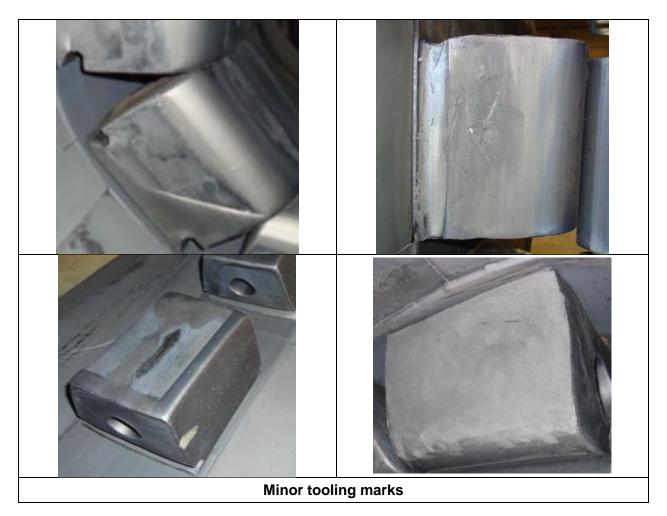
7.3 Guide Lug

NON-WARRANTY CAUSE: Normal manufacturing process-due to minor manufacturing defects, environment or minor mechanical damage.

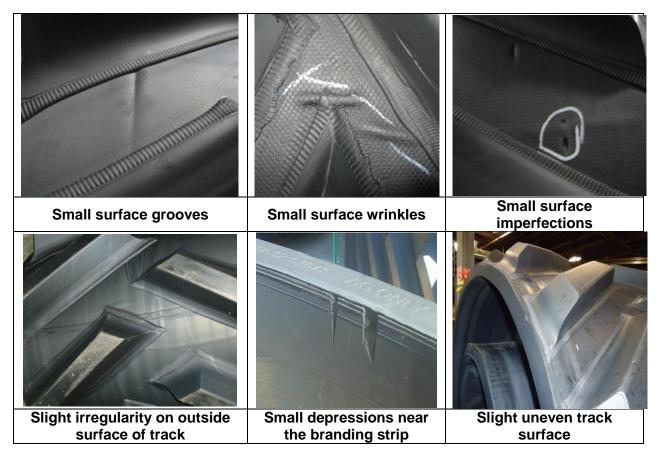
7.4 Carcass

NON-WARRANTY CAUSE: Normal manufacturing process-due to minor manufacturing defects, environment or minor mechanical damage.

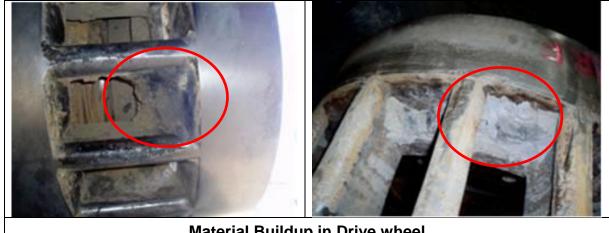
Material Buildup in Drive wheel

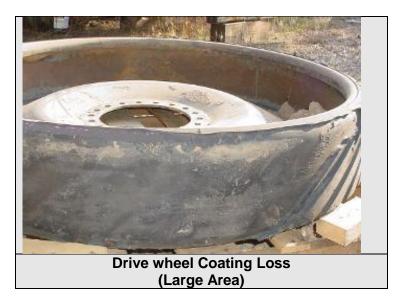
WARRANTY CAUSE: Poor manufacturing process control

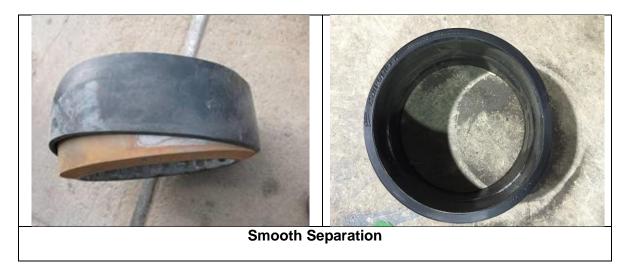
WARRANTY CAUSE: Poor adhesion to steel or casting

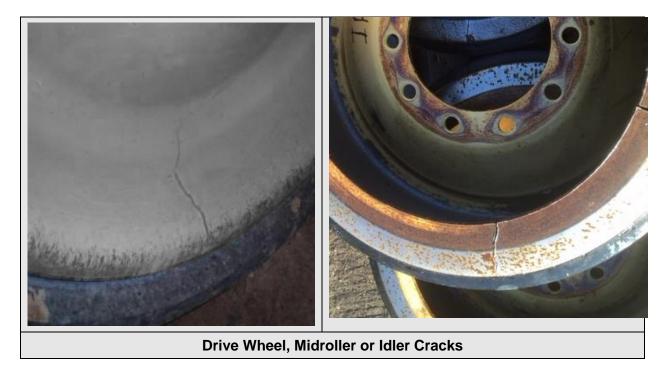
WARRANTY CAUSE: Steel defect. If caused by stress concentration, it will originate from a defective area that can be identified upon inspection and will occur at lower operational hours.

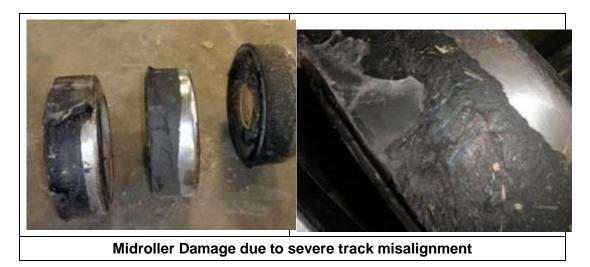
NON-WARRANTY CAUSE: Excessive heat due to track misalignment or steep side slope operation. This coating loss will be seen on the side of the midroller next to guide lug.

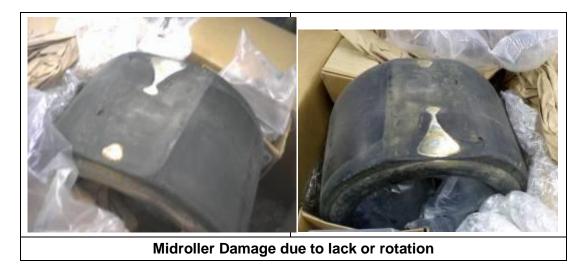
NON WARRANTY CAUSE: Excessive heat and abrasion due to loss of rotation on midroller during operation. Midroller rubber loss due to lack of rotation can occur from:

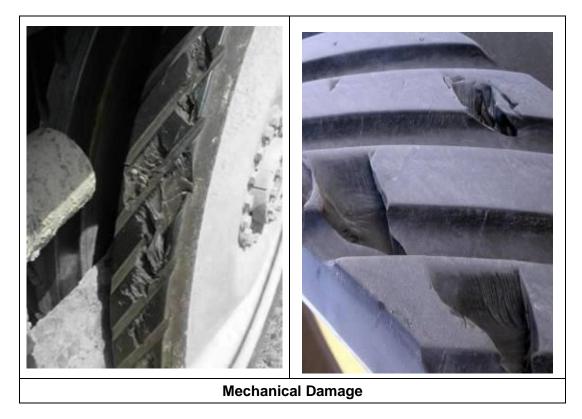
NON-WARRANTY CAUSE: Material ingestion, cutting, or other damage due to debris. In some cases, may also be heat and load related.

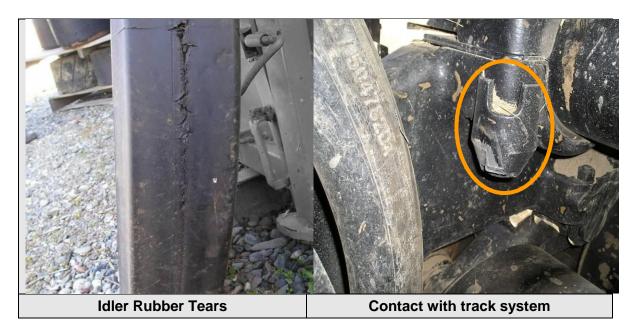
NON-WARRANTY CAUSE: Mechanical damage from front idler recoil event causing track frame contact.
