PRODUCT FAILURE ANALYSIS

TIRES AND WHEELS

Issue date: September 1, 2015 V8

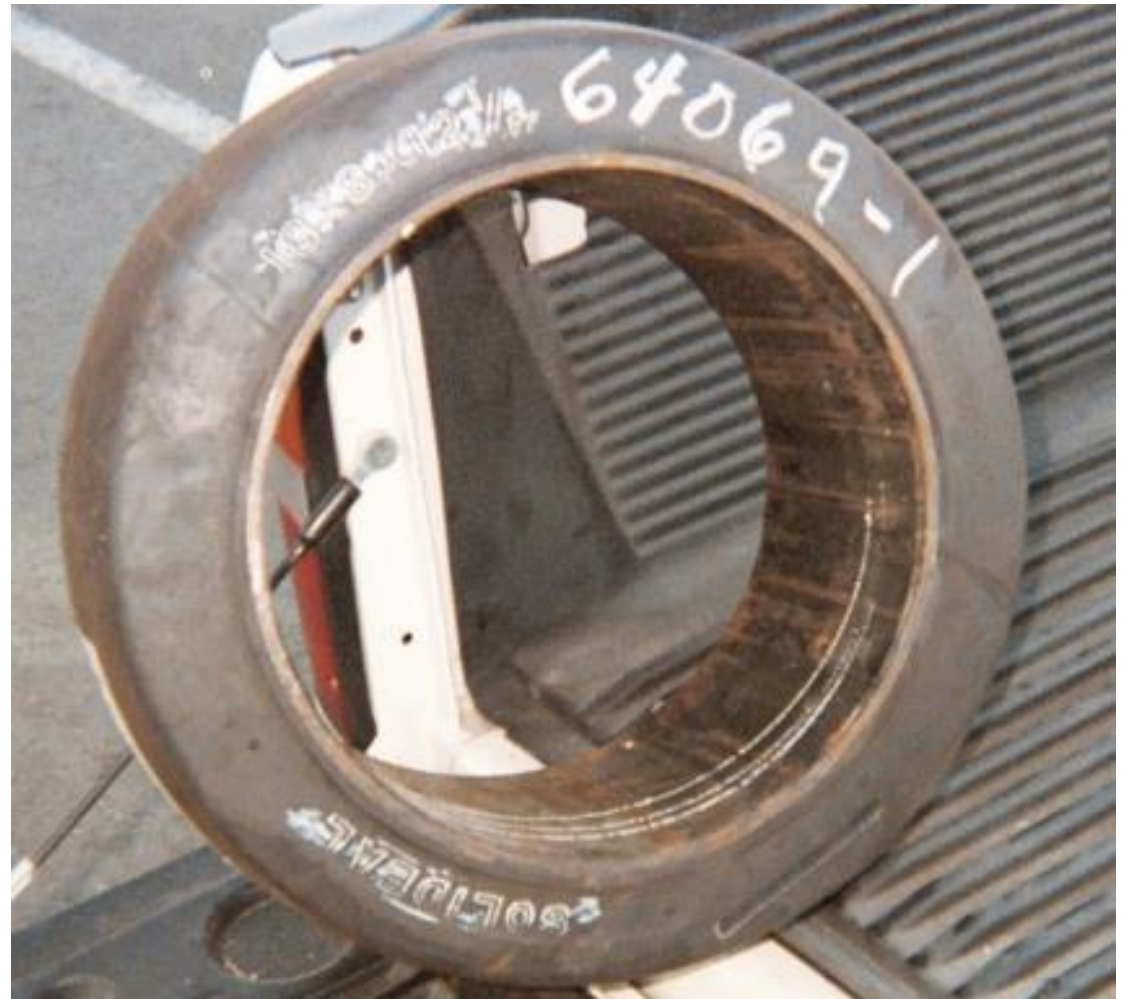
A04: STEELBAND SIZE TOO SMALL

Damaged steelband

- Tire size too small for rim
- Steelband size too small

- Check if tire size is the correct for the wheel
- Check rim for deformation and damages

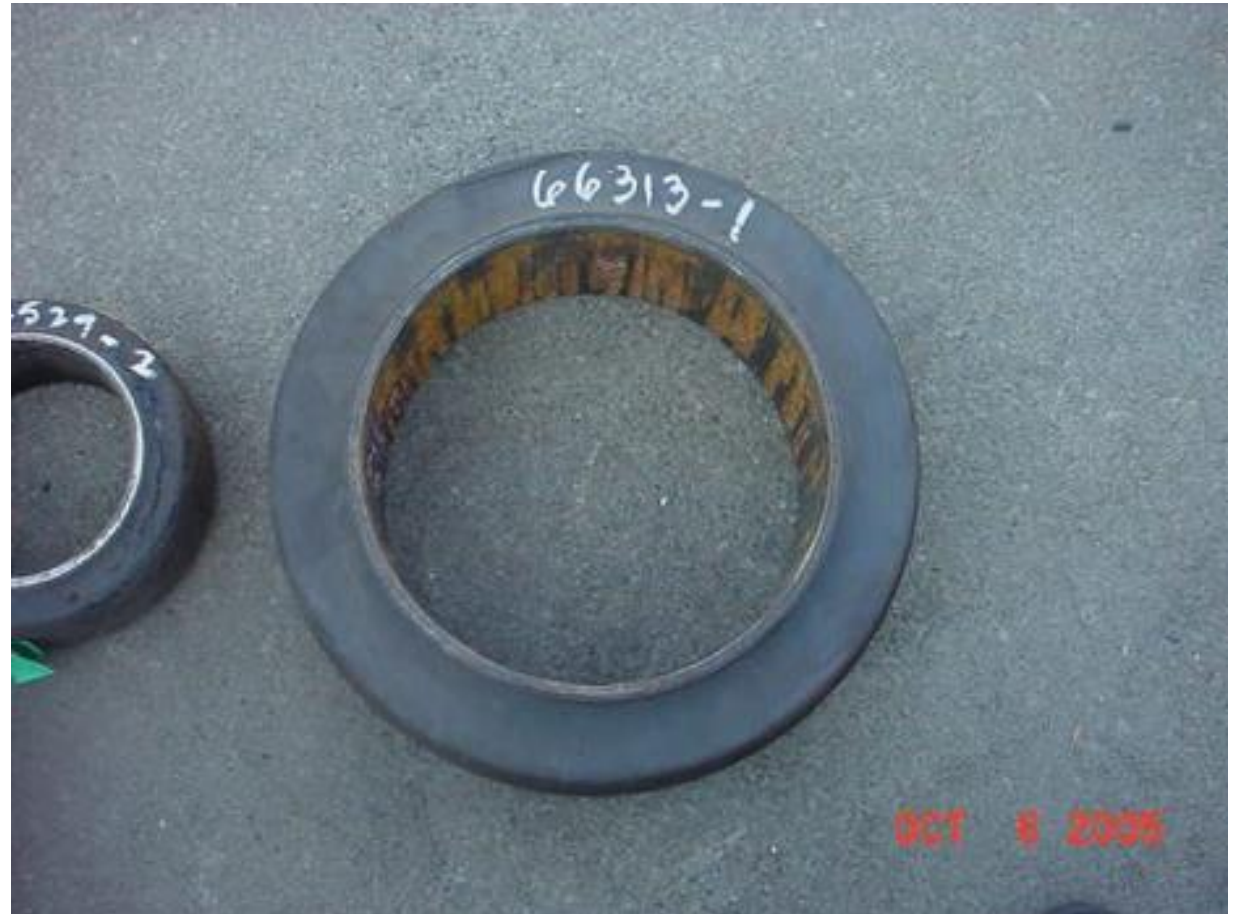
A05: STEELBAND OVAL

Steelband Oval

- Tire dropped on floor

- Handle PON with care, avoid damage during transport

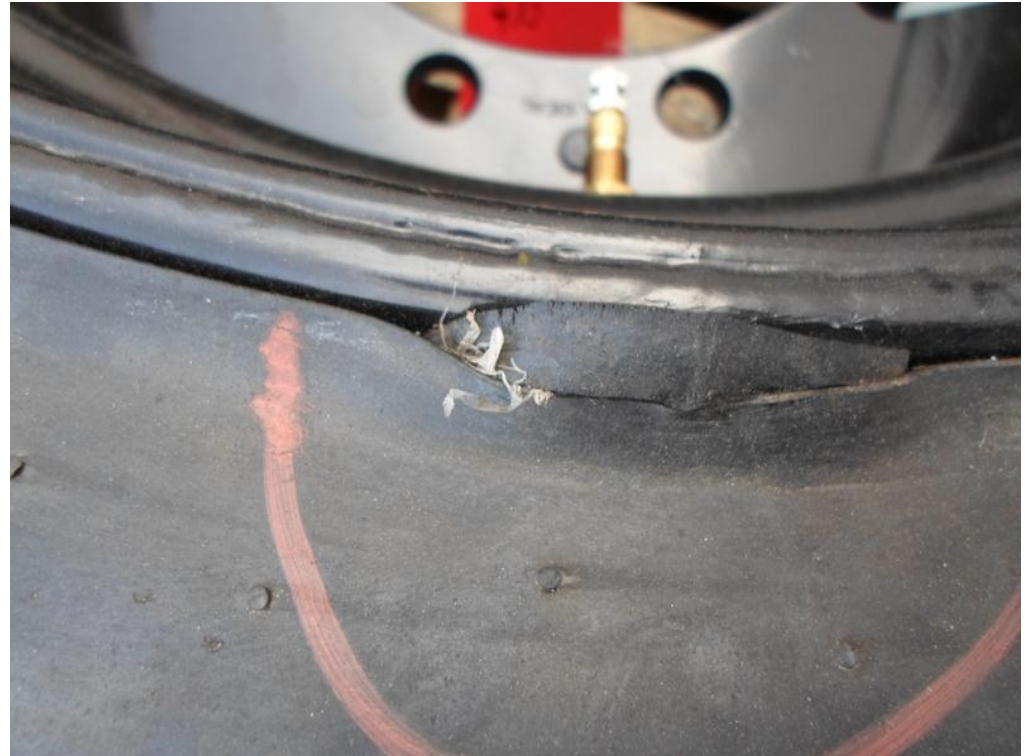
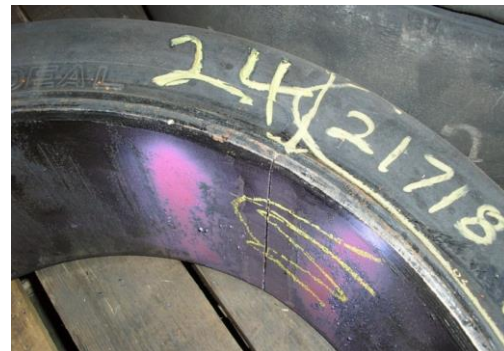
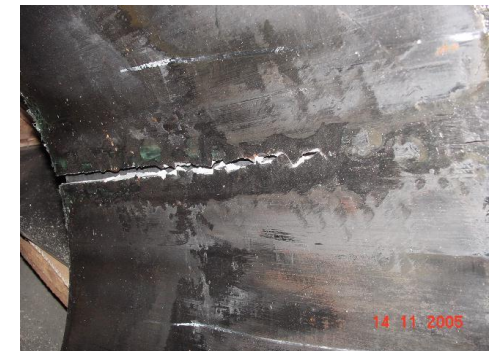
A06: BROKEN STEEL BAND (STB) OR BEADS

Cracks in Steelband or Beads

- Steelband too small
- Bad mounting
- Rim deformed/damaged
- Rim too big

- Check wheel(size, damages, deformation)

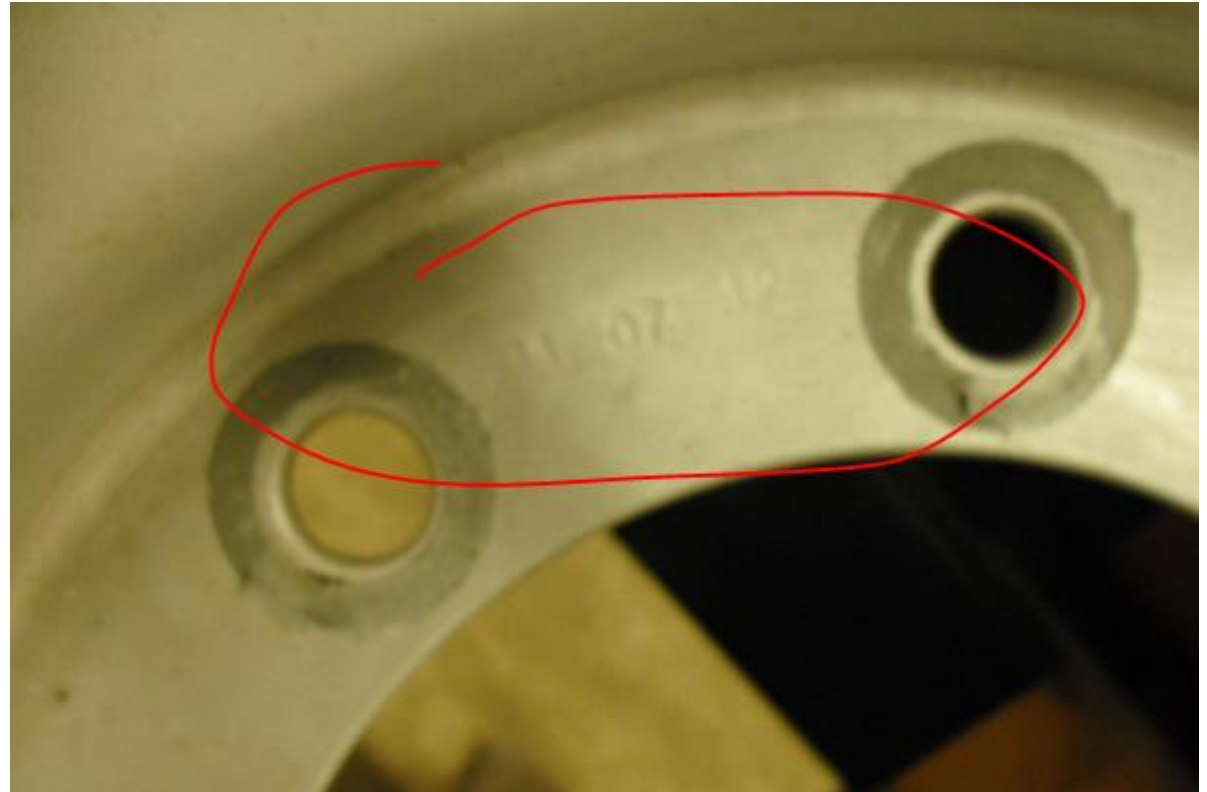
B05: STAMPED MARKINGS

Stamped markings are; incorrect for the product, not ledgeable or missing completely.

- Operator or equipment not functioning properly

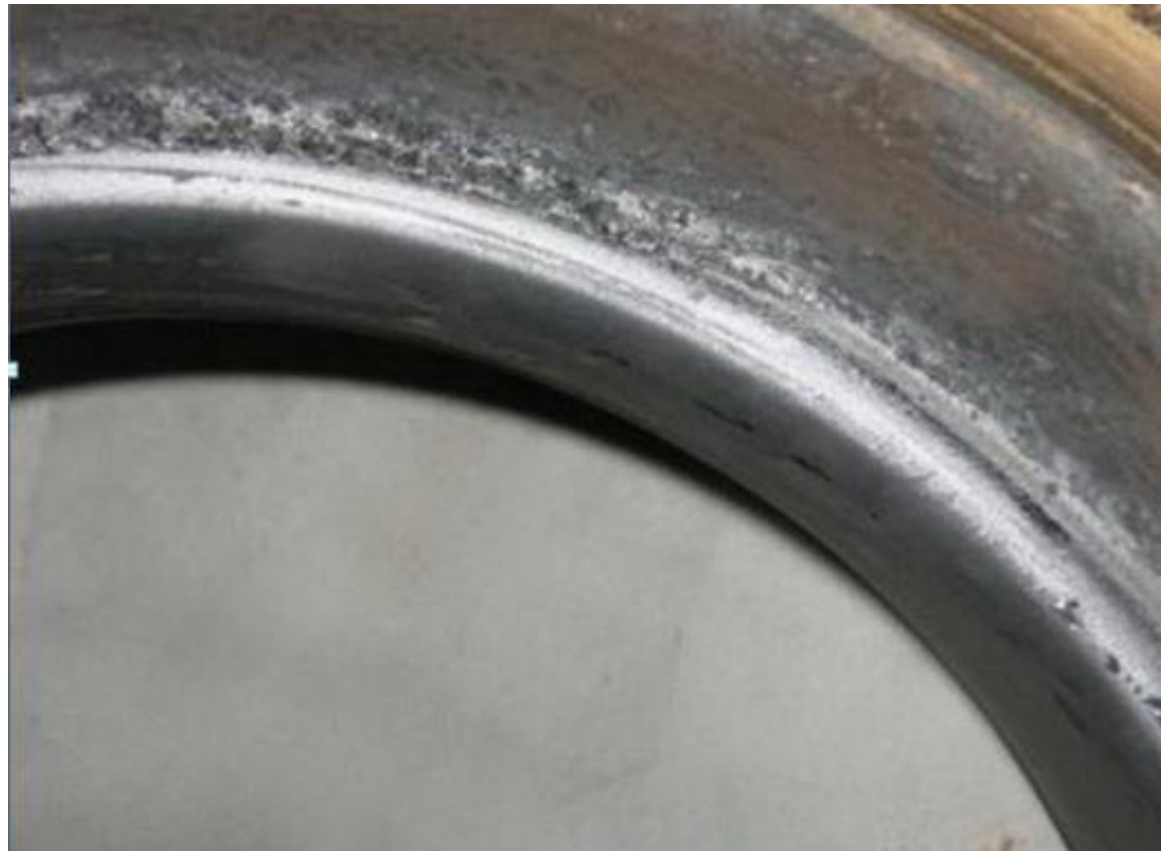
C01: SPINNING ON RIM

Damaged band / bead or heel

- Tire slippage occurs when the tire moves on the wheel
- Can occur during braking or while running (jack rabbit starts/hot shifting)
- Slippage can be detected by marking the tire and rim at the same spot with chalk or paint
- Safety issue due to decreased braking ability of the truck
- When slippage occurs the tire must be removed, and it is possible that new wheels need to be mounted as well
- In all cases of tire/rim slippage, the tire must be demounted to analyze the causes

- Remove tires from service

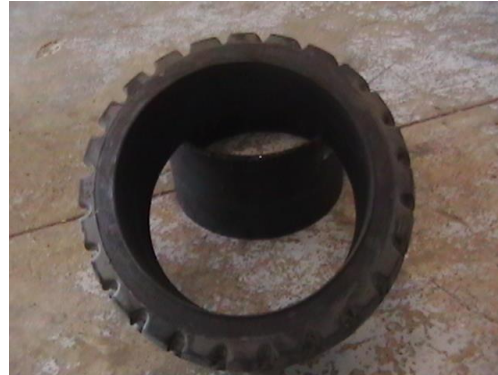
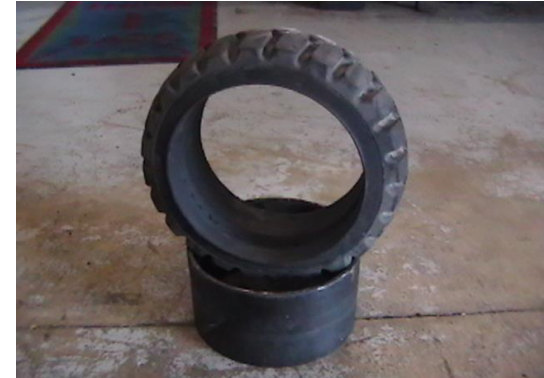
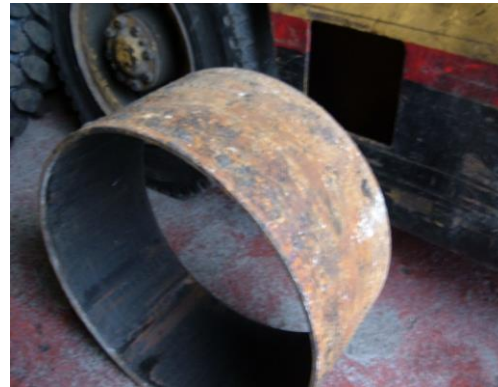
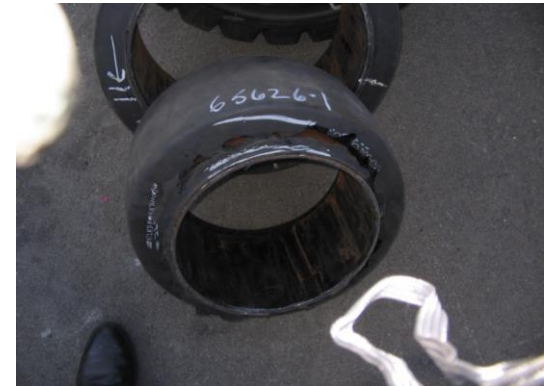
C02: BONDING TO STEEL FAILURE

Cracks between rubber and steel band
or wheel if mold on
Rubber detached from steel band or wheel

- Overload
- Insufficient adhesion agent
- Welding on steel band
- Contamination of bonding surface

- Fit the appropriate tire size for the specified load
- Do not weld on the steel band

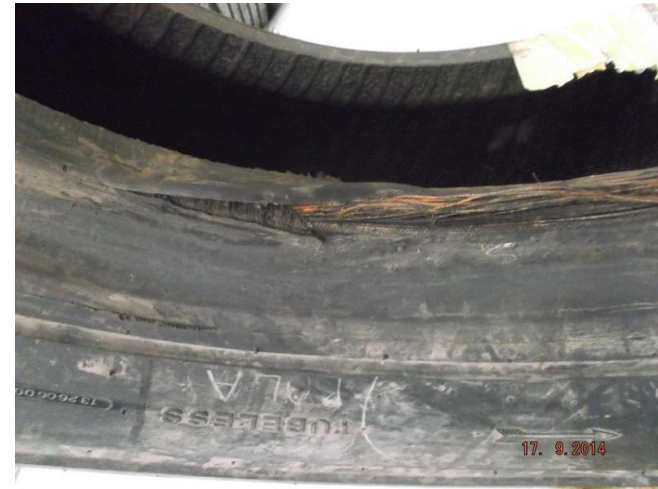
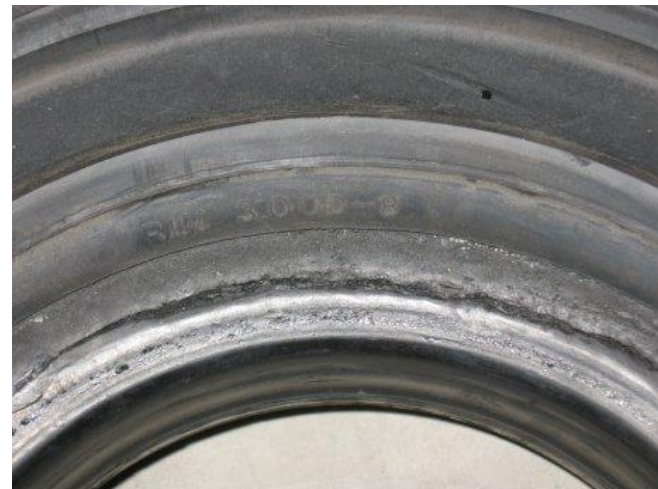
C04: BEADS BREAKING OUT

Circular cracks in heel. This kind of damage is detected during the first period of tire utilization

- Bad pressing, or mounting
- Bonding failure

- Use supporting ring for pressing operation, and correct mounting tools for pneumatic tires
- Avoid over pressing

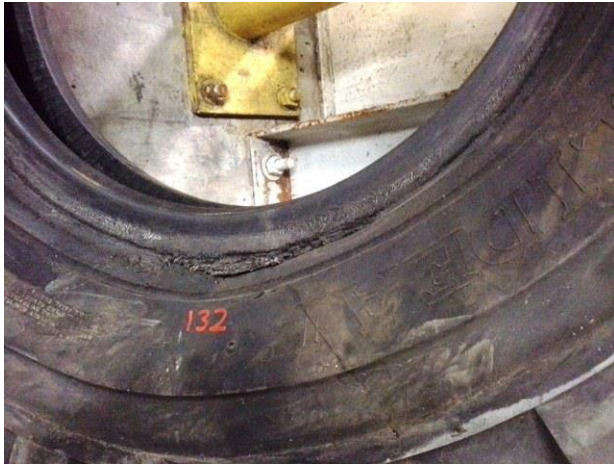
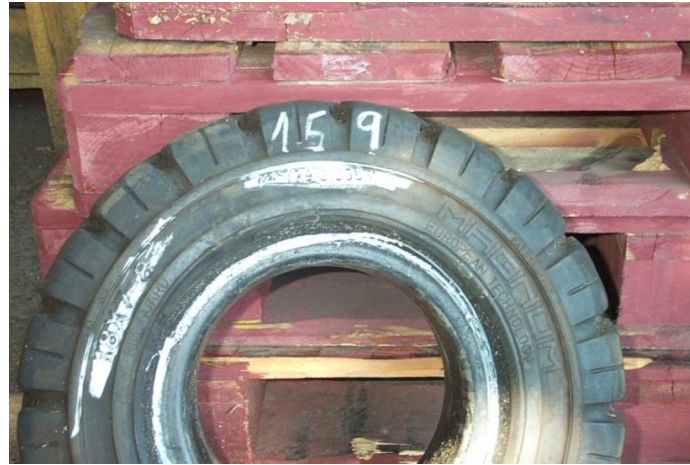
C05: EXC. WEAR OF BASE ABOVE RIM HOOKS OR BEADS

Cracks in heel above rim hooks

- Overload
- Soft rubber from middle layer in heel or bead area

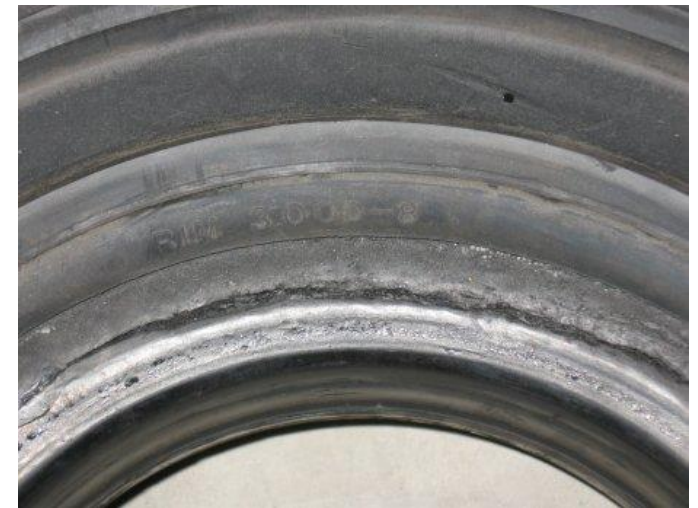
C06: RADIAL CRACKS STARTING IN BASE

Radial cracks Starting in base, and widening towards tread

- Overload

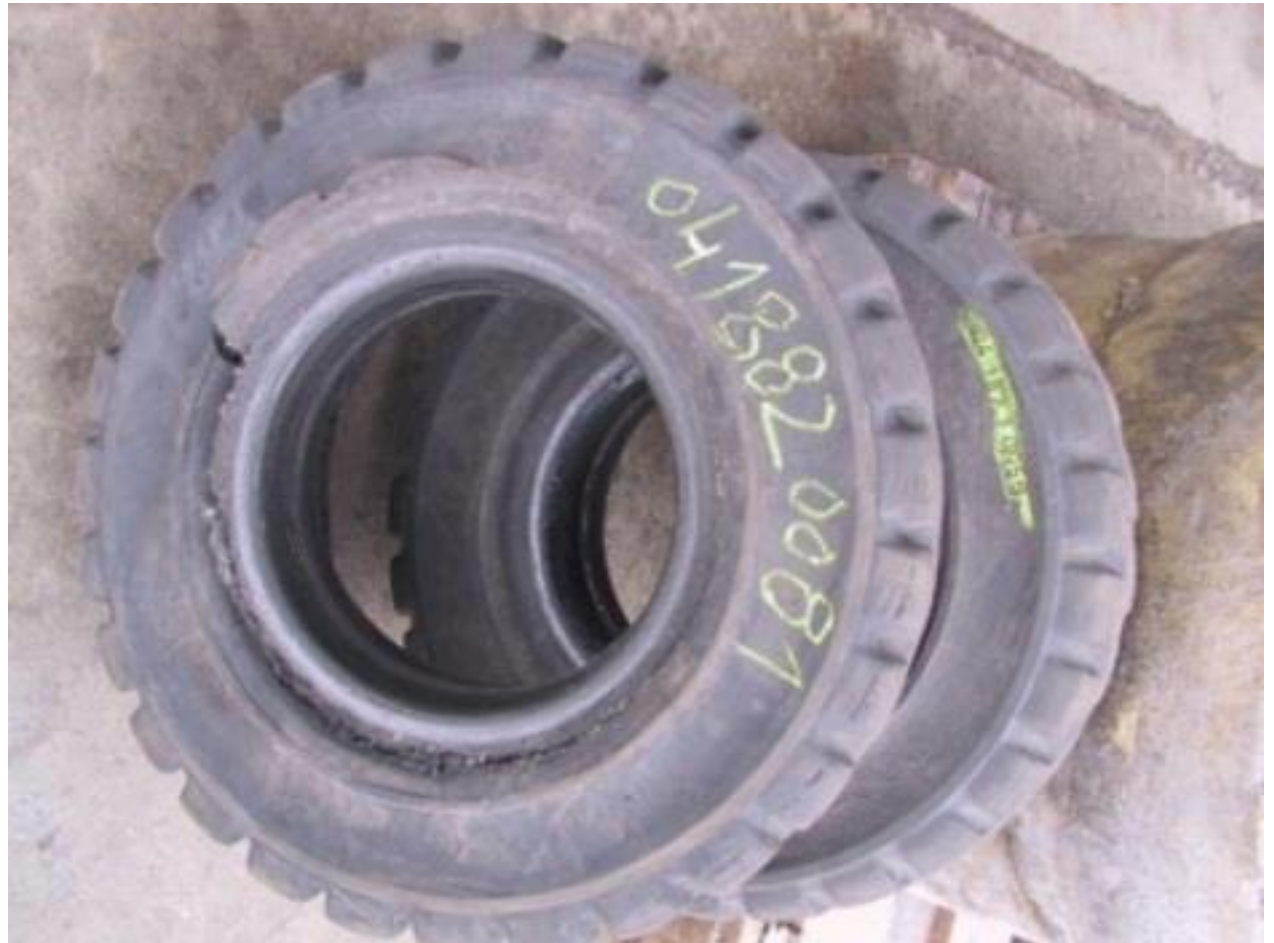
C08: BONDING FAILURE BASE TO MIDDLE LAYER

Separation between heel and middle layer

- Insufficient adhesion

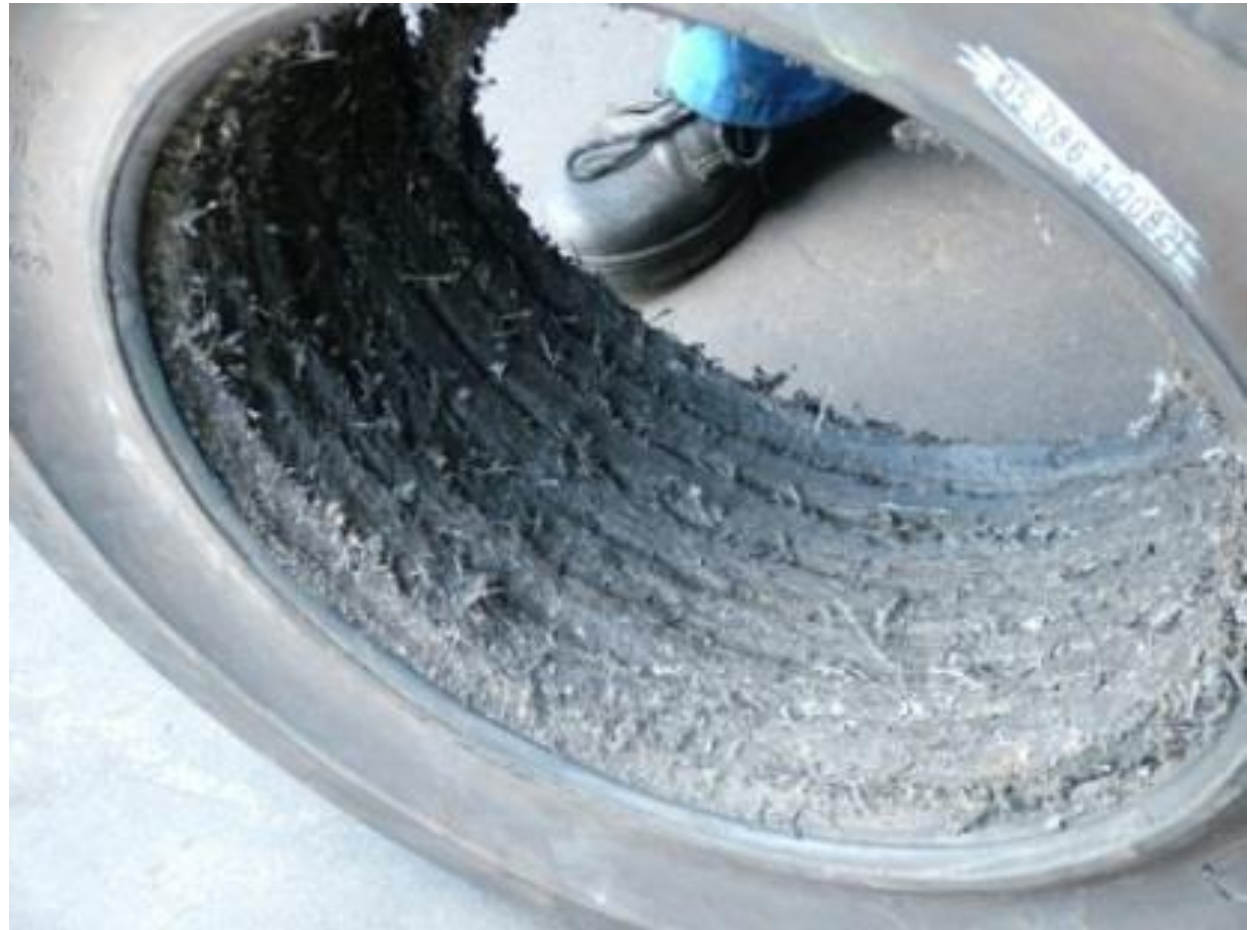
C10: BROKEN OR WORN OUT NOSE

Nose worn out or broken

- Too high lateral force
- Nose damaged during mounting
- Overload (combined drive / steer tire)

- Use appropriate mounting tools, (mounting cone, mounting paste, etc...)

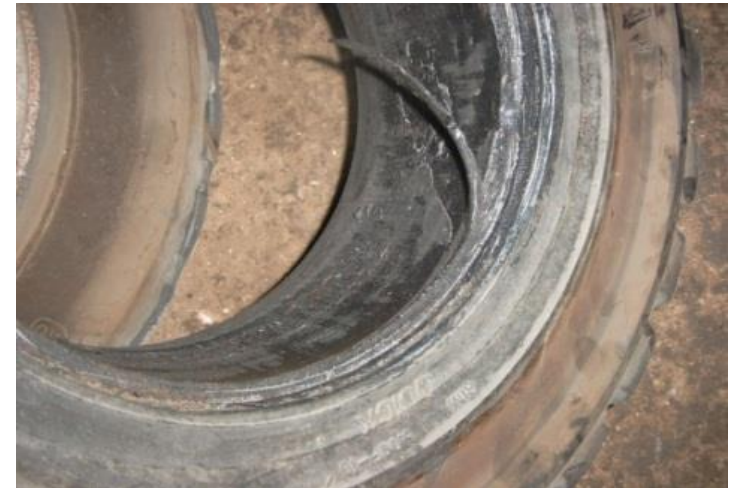
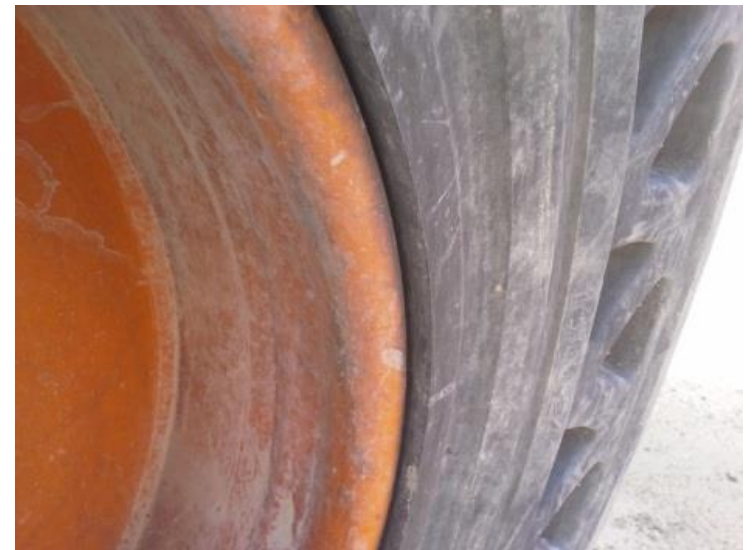
C11: DELAMINATION IN HEEL

Heel drops out of tire
(smooth surfaces are visible)

- Bonding failure between rubber layers in heel (issues during tire building process)

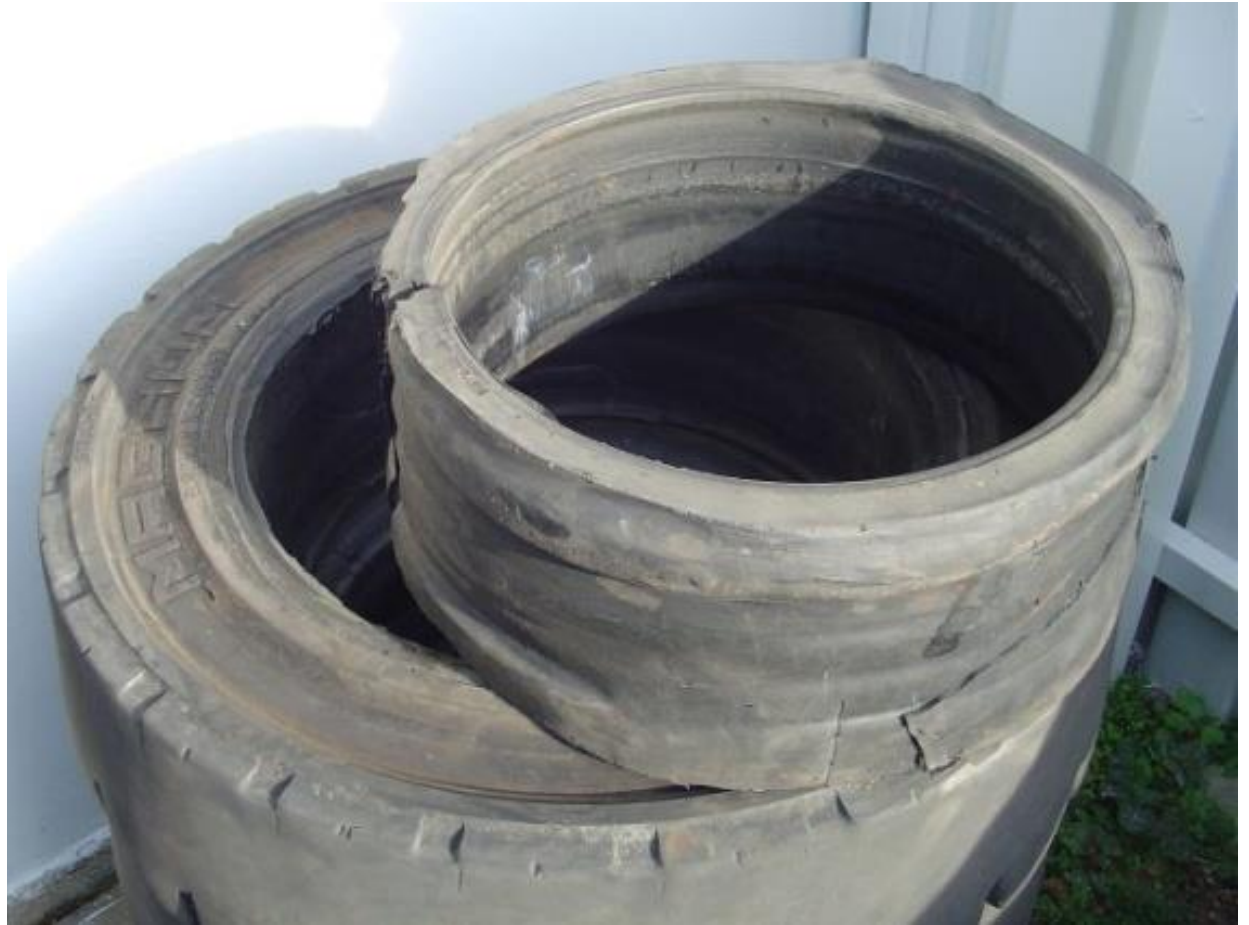
D01: CIRCUMFERENTIAL CRACK

Crack around circumference of tire

- Short mold or mold heat dispersion problem causing flow issue

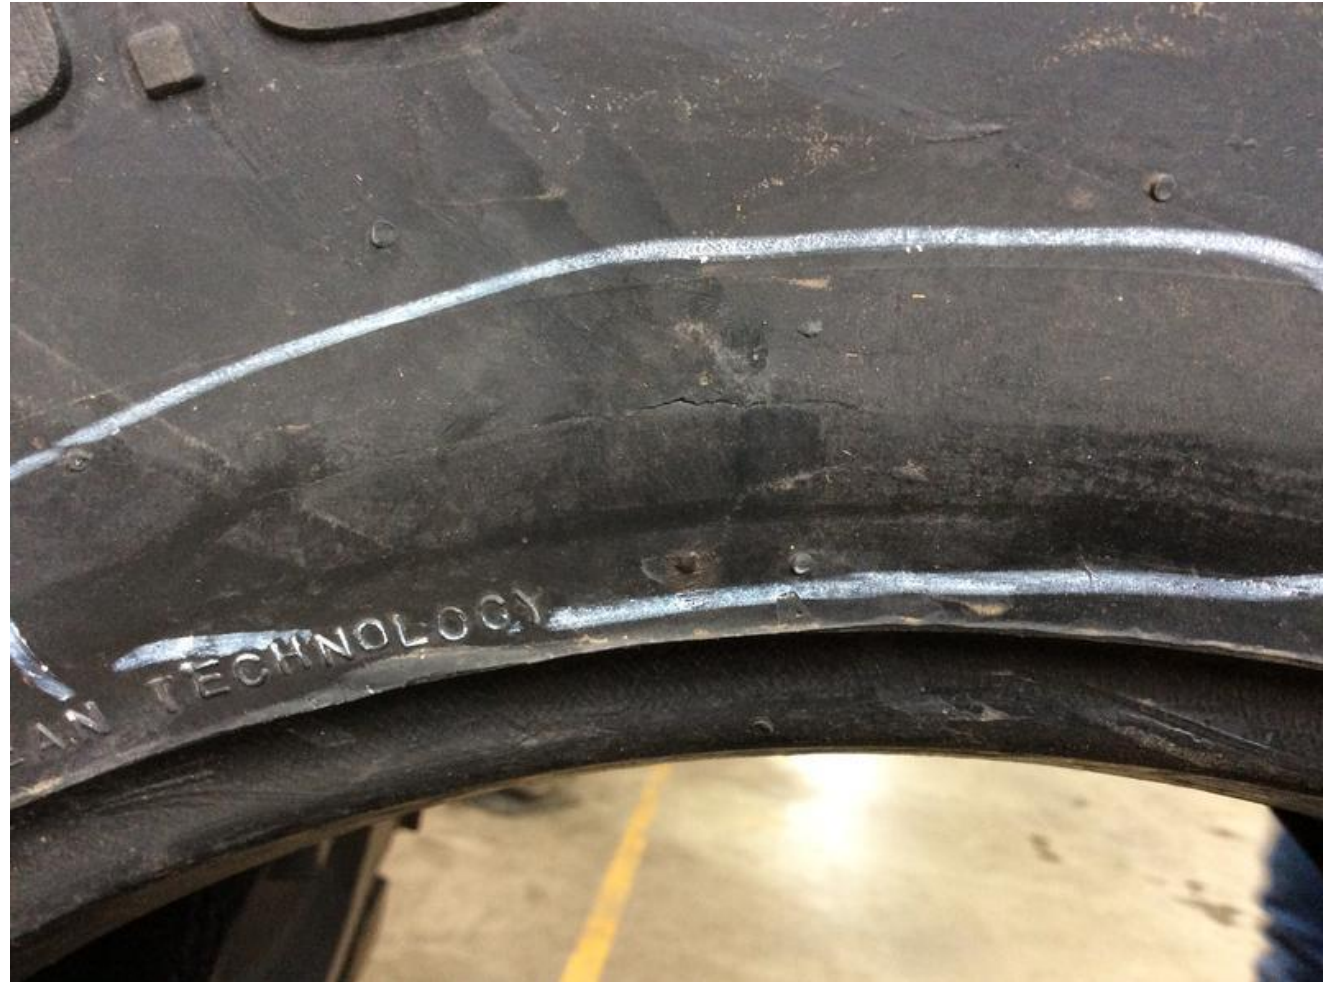
D02: SIDEWALL DAMAGE

Light to severe wear or damage of the sides of tire

- The sides of the tire get damaged by the OTT. The OTT rubber is harder than the tire rubber. Result is that the sidewall of the tire gets worn
- Tire pressure too low – underinflated tires will bulge more and wear sidewalls
- Interference between wings and tire carcass, check for debris
- Bad alignment between front and rear tire, check nave plate spacing
- Bent wheel or nave plate will cause misalignment
- General damage to the sidewalls of the tire

- Check tire pressure
- Check rim condition
- Check alignment between front and rear tire
- Check wheel offset

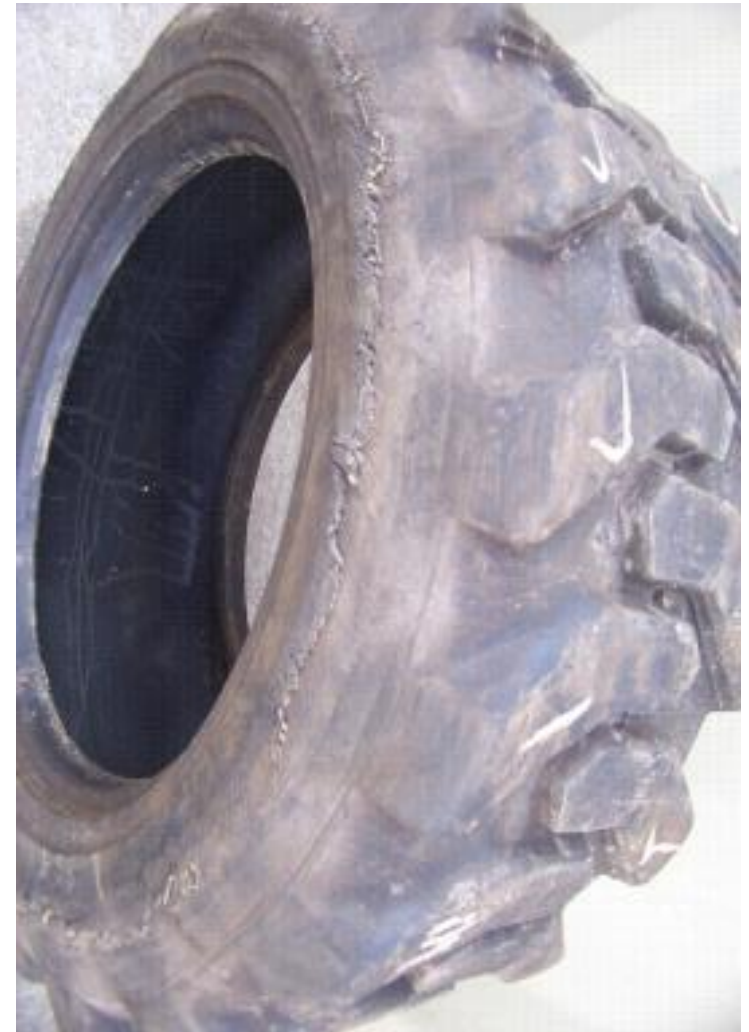
D03: BROKEN MIDDLE LAYER

Middle layer damaged/broken

- Bad middle layer compound

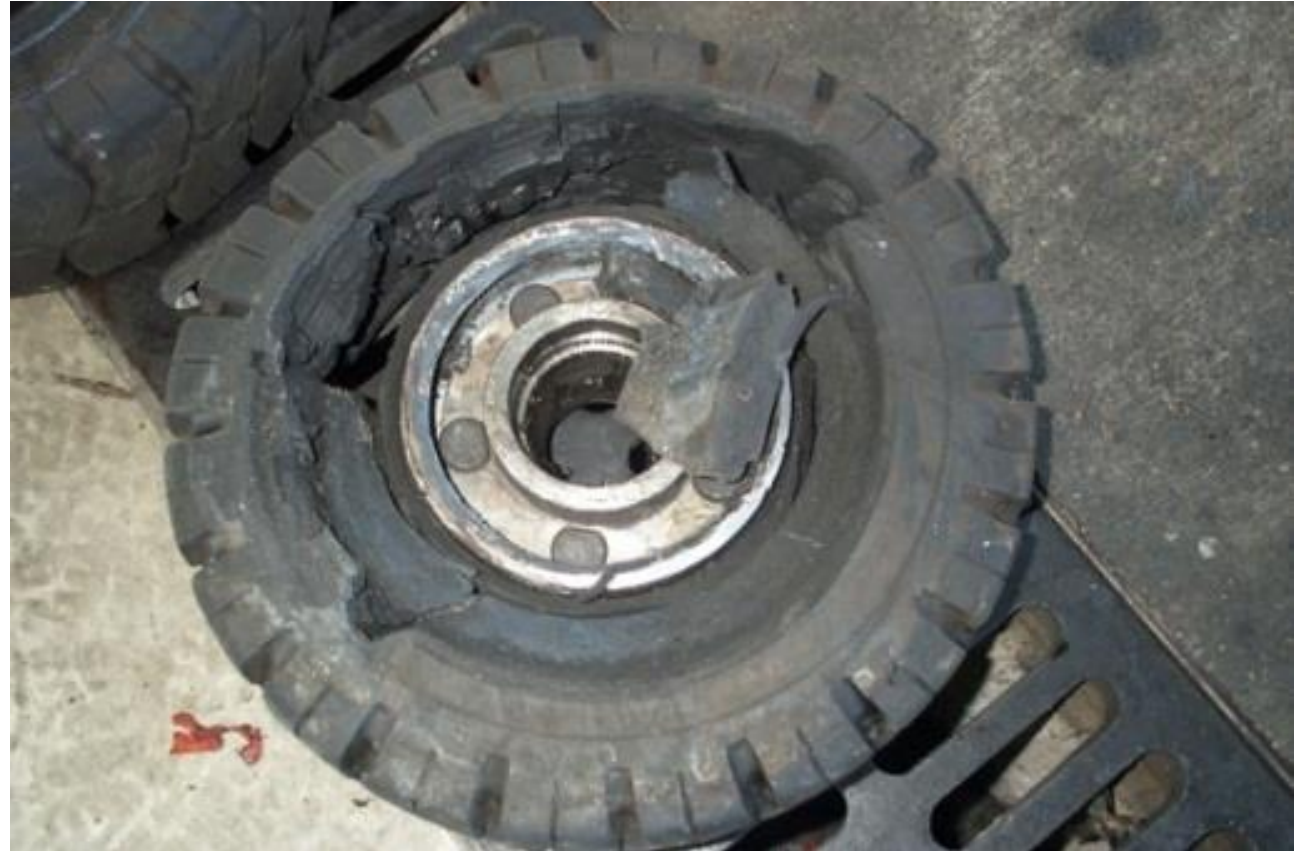
D04: RADIAL CRACKS STARTING IN MIDDLE LAYER

Radial cracks

- Overload

- Check axle loads for both loaded and empty conditions
- Check if the truck has been equipped with extra weight or special attachments
- Reduce the carried load, if possible
Note: steer tire overload occurs when a truck is carrying loads that are significantly less than what it is rated to carry
- Use proper tire size (larger, wider), or use a “high load” compound
- Possibility to use larger forklift?

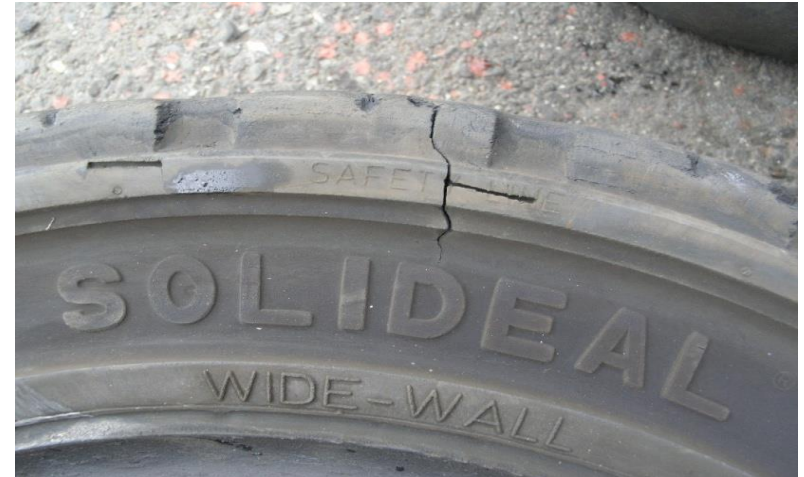
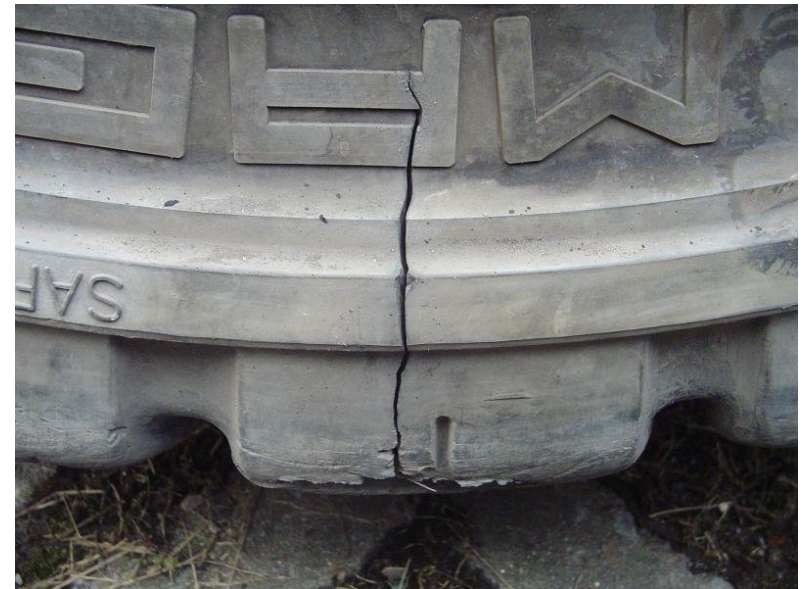
D05: PERMANENT DEFORMATION

A permanent abnormality in the construction of the tire

- A lapse in manufacturing methods or materials

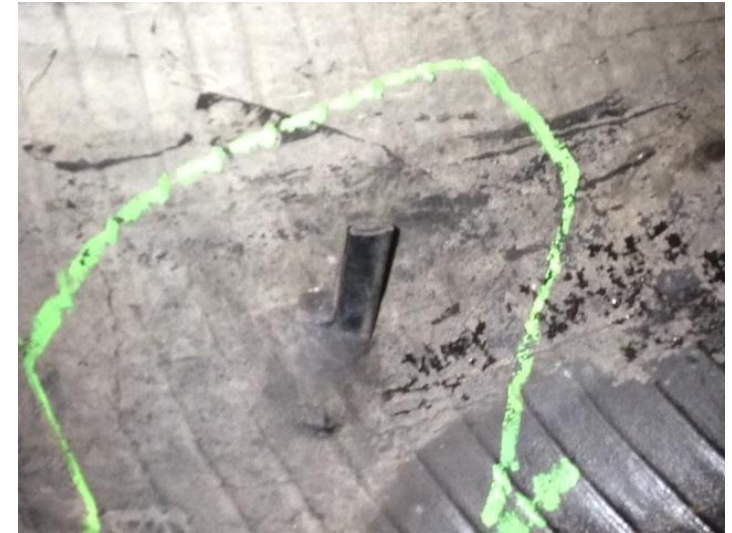
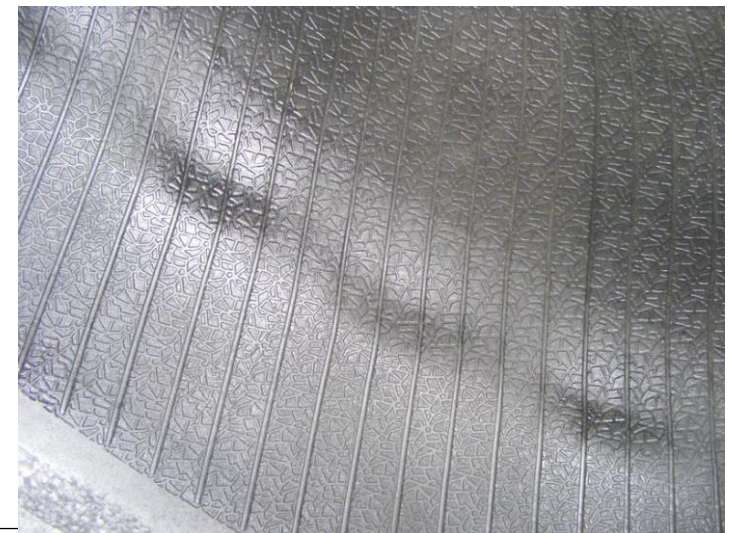
D06: BONDING FAILURE MIDDLE LAYER

Circular separation in the middle layer, between tread and middle layer

- Poor preparation or contamination between middle layer rolling and tread layer rolling at production

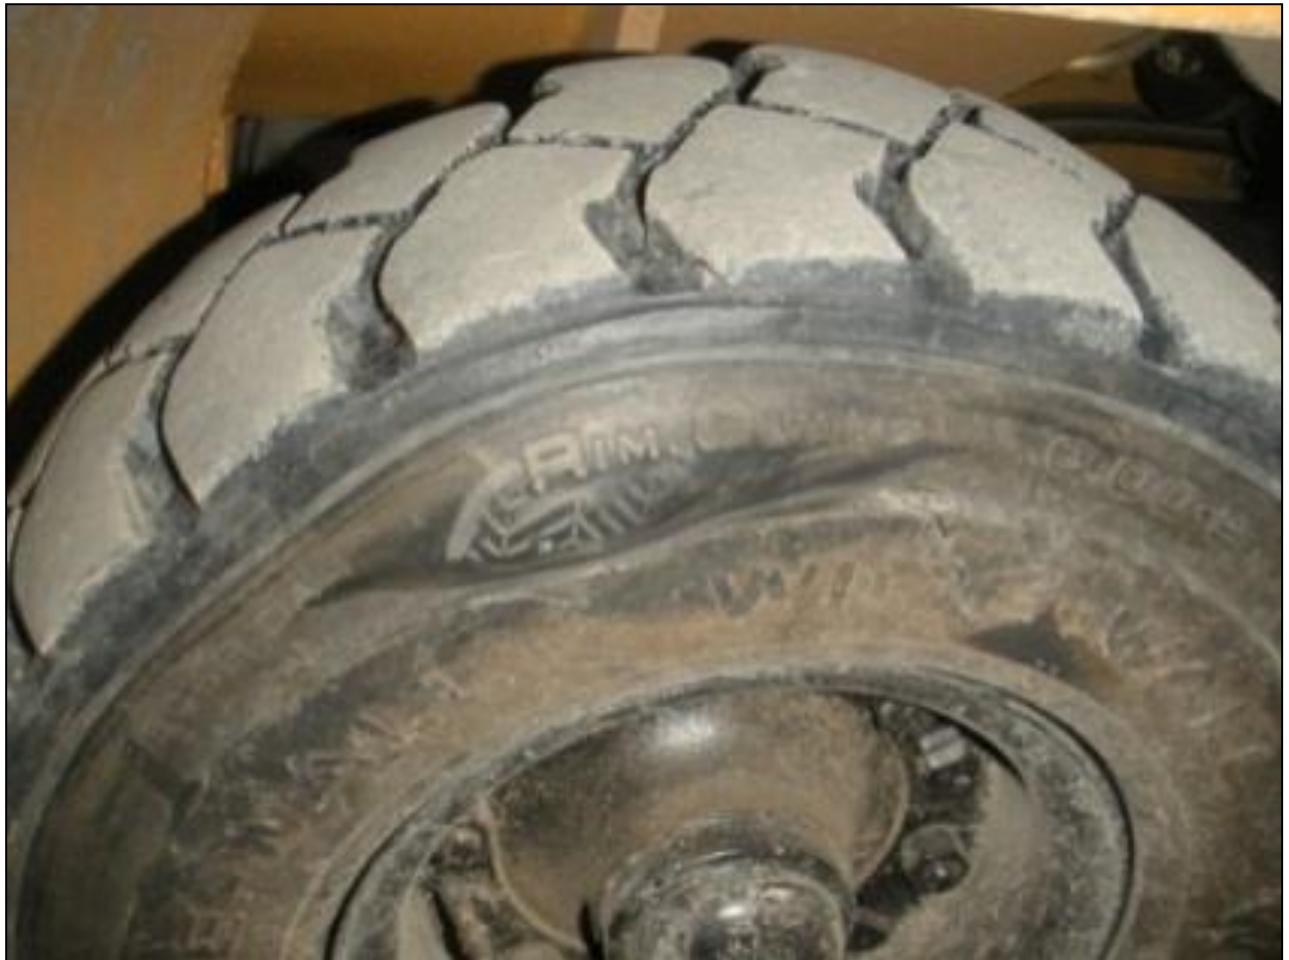
D08: LAYERS OF CASING APART

Casing appears to be coming apart in layers.

- Precured rubber during tire building process
- Contamination between the layers
- Impact damage

- Avoid impacts if applicable

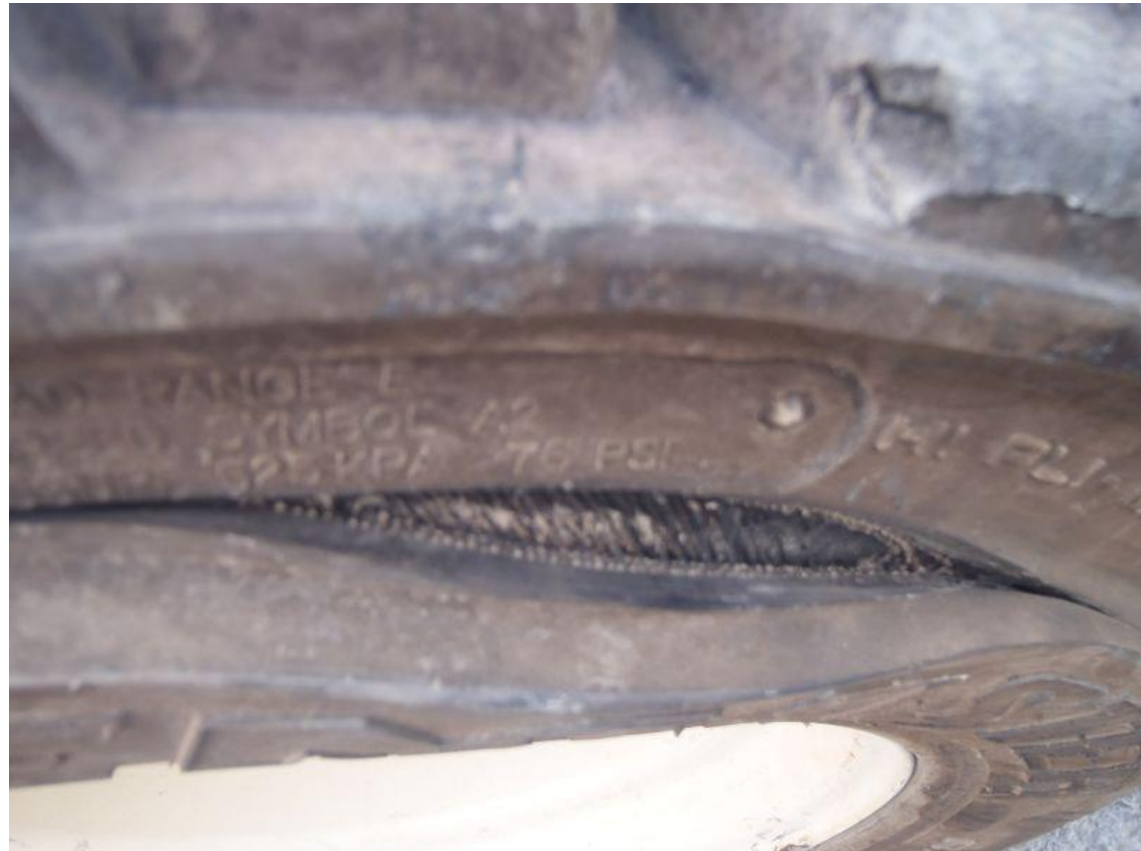
D09: LAMINATION IN CENTRE (PRECURE)

Separation between rubber layers (layers of rolled rubber visible)

- Precure due to too high temperature during middle layer rolling

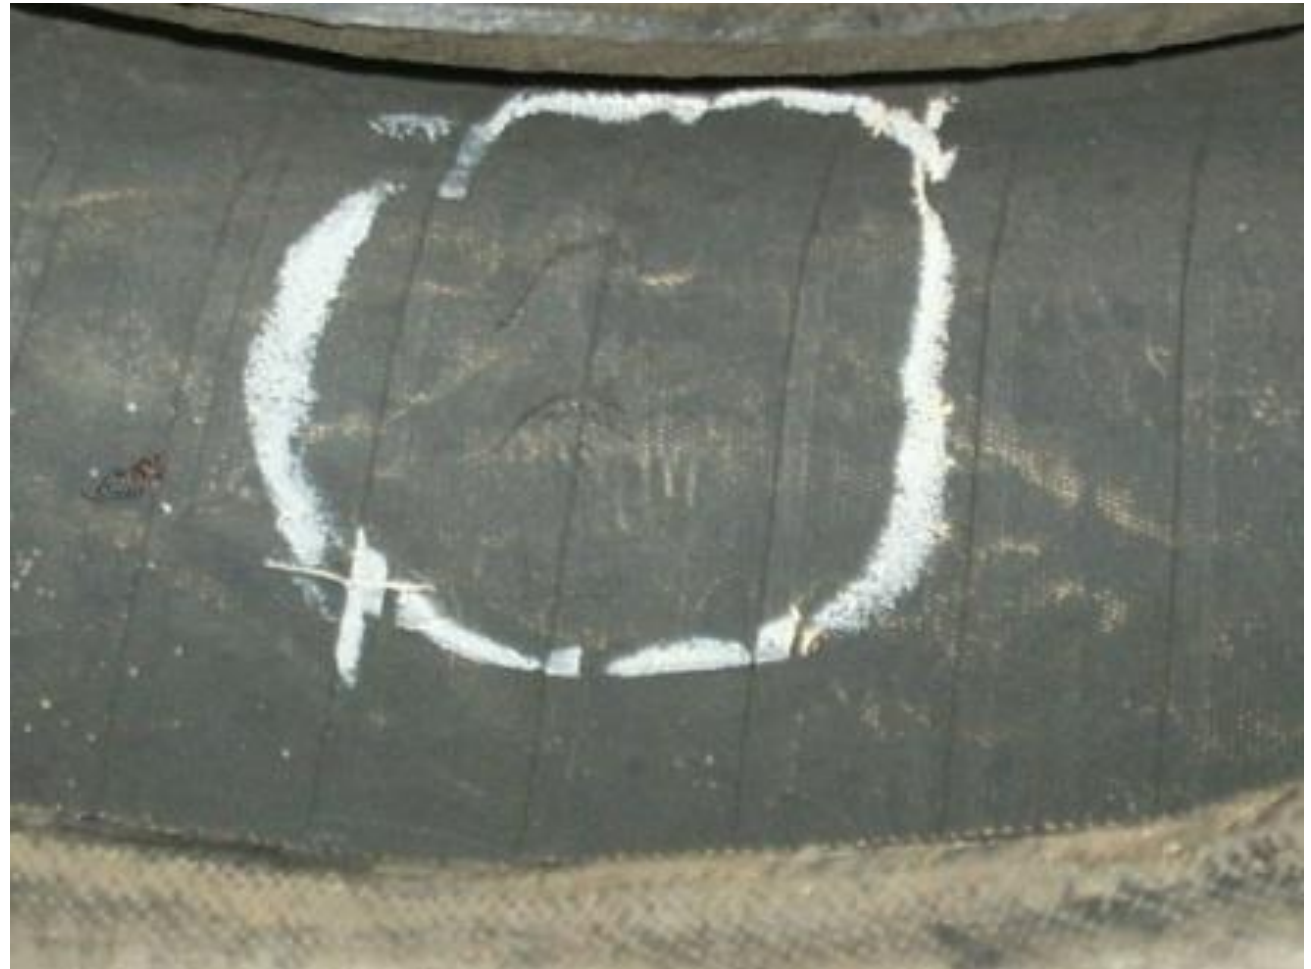
D11: AIR LEAKAGE

Noticeable leakage either audible or visual

- Porous liner

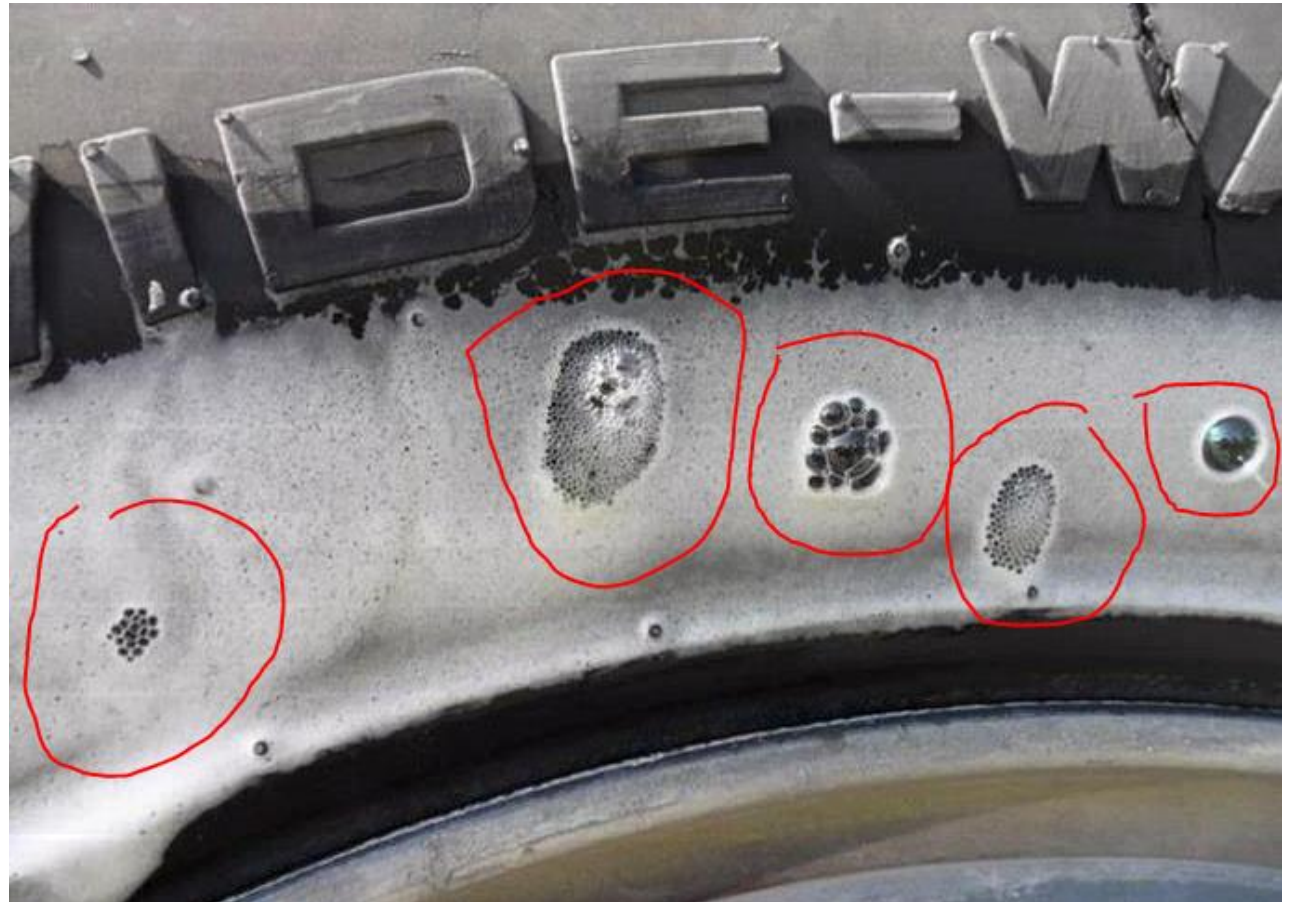
Air leakage shown by, adding soapy water to the tire's sidewall
