PRODUCT FAILURE ANALYSIS

TIRES AND WHEELS

Issue date: September 1, 2015 V8

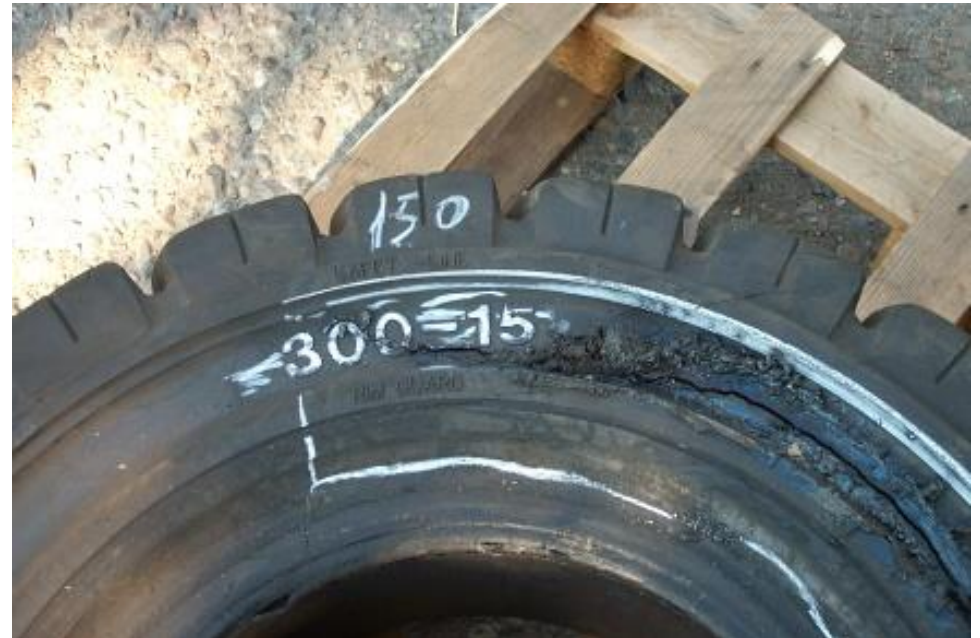
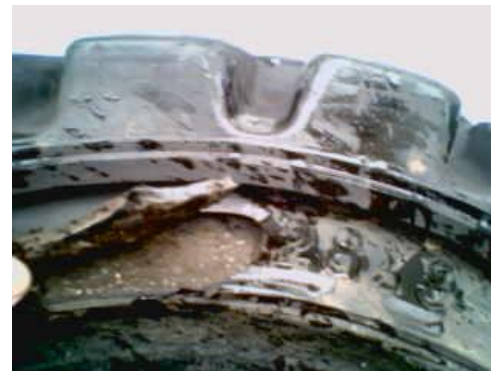
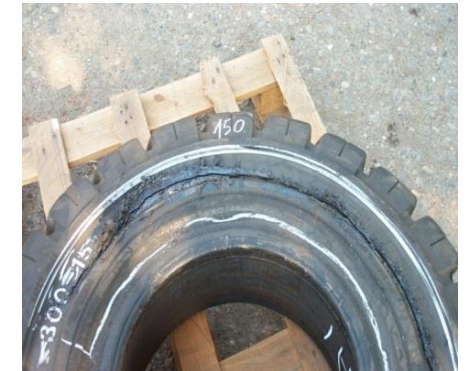
E01: IMPACT DAMAGE RESILIENT TIRES

Cracks on tread lugs
Rubber pieces pulled out of treads

- Impact damage

- Customer training, customer awareness

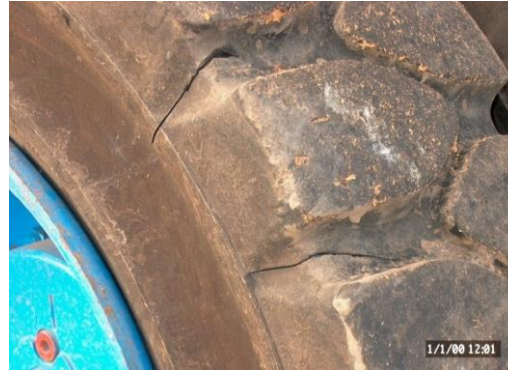
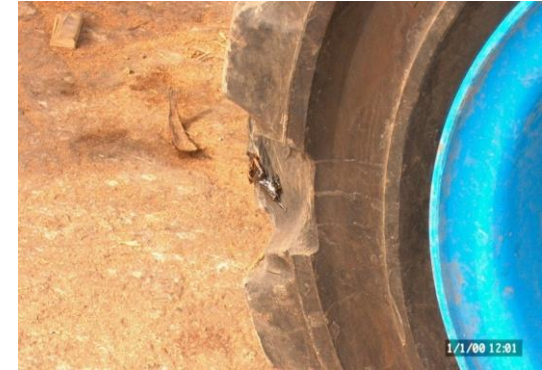
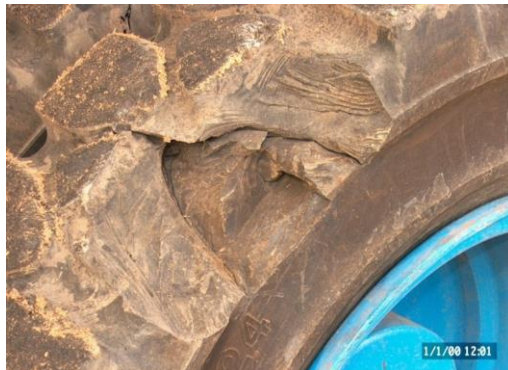
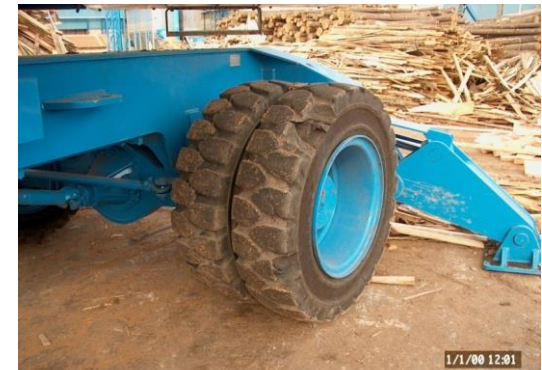
E01: IMPACT DAMAGE PNEUMATIC TIRES

Cracks on tread surfaces
Cracks at inner layer

- Impact damage
See pictures

- Customer awareness

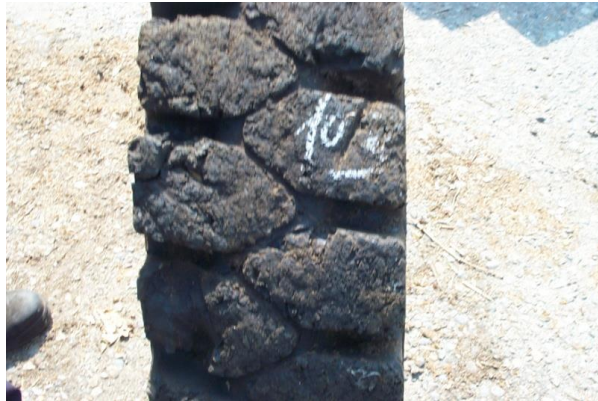
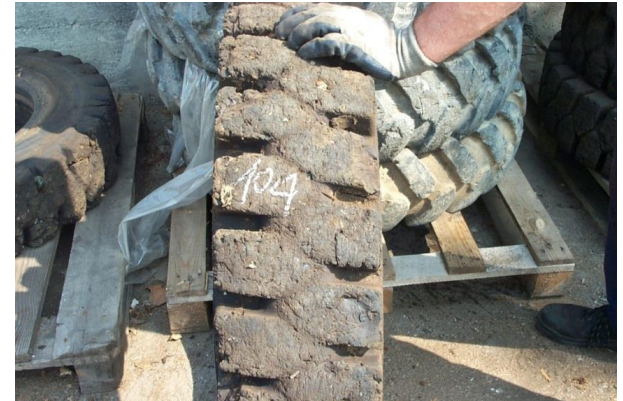
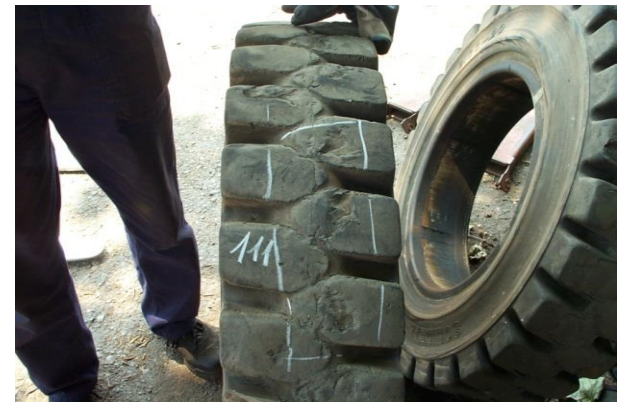
E03: LUG CRACKING OR BREAKING OUT

Pieces of lugs breaking and or cracking at the basis

- Application related (hitting a foreign object)

- Operator awareness

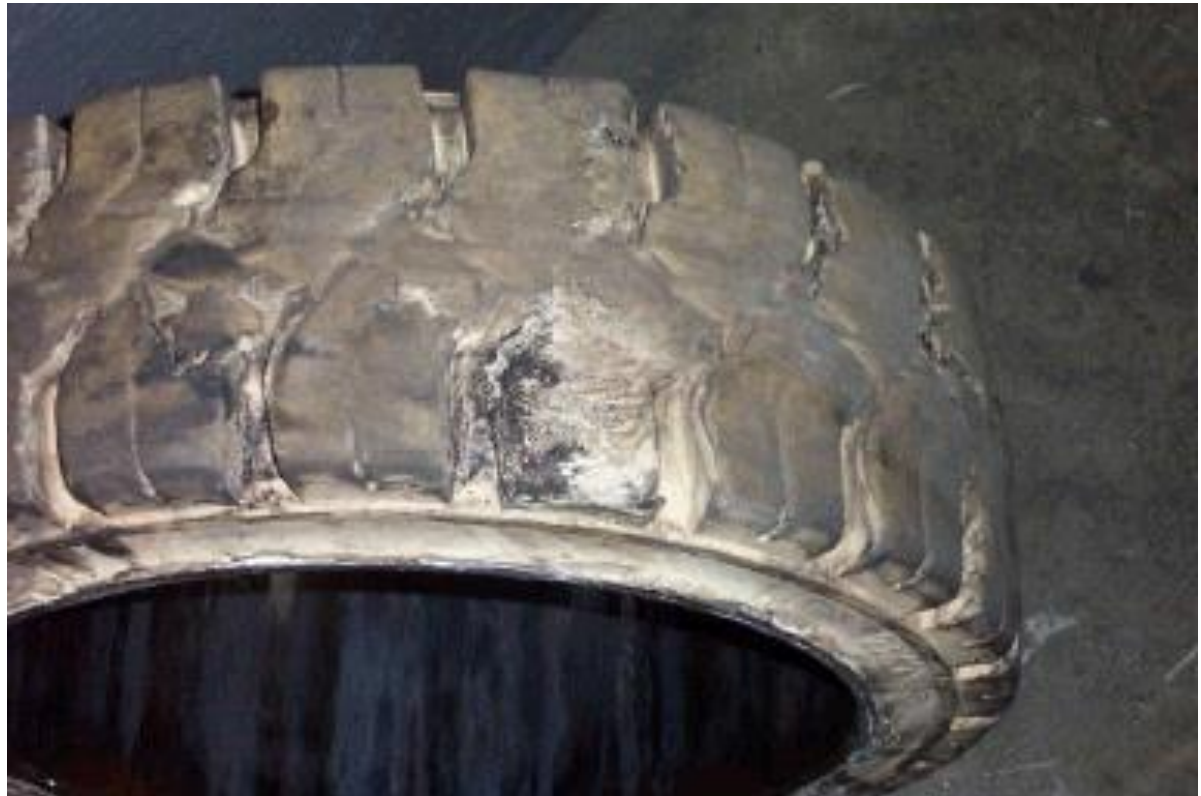
E04: UNEVEN WORN LUGS

Lugs are worn in an uneven manner from front to back, side to side, or grooved

- Application related wear due to roading, loading and operation, or other(see rail application photo).

- Operator awareness
- Select appropriate tread profile in the case of WEX for rails. Smooth tire for the one in contact with the rail or roller

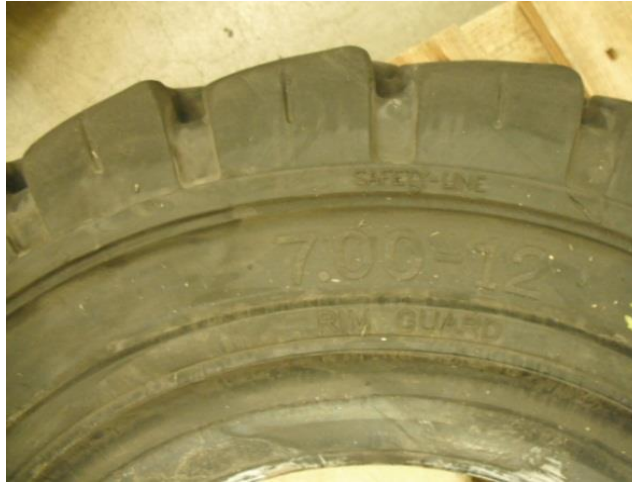
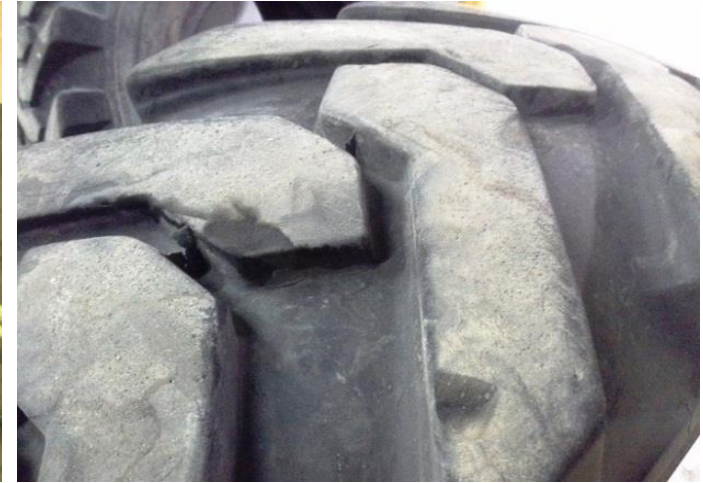
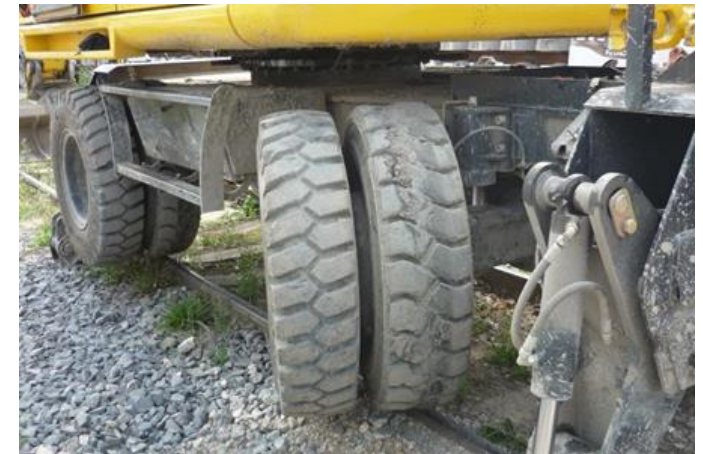
E05: TAPERED WEAR

Lugs are more worn
at one side then at the other

- Wrong camber angle
- Wrong steering angle
- Axle misalignment (damaged)
- Unequal or improper inflation pressure
- Different compounds/treads/
brands/OD on axle
- Application (turning preference)
- Dual mounting

- Check camber angle
- Check steering angle
- Check alignments
- Monitor inflation pressure
- Never mount different tires on 1 axle
- Rotate tires left/right
- Turn tires on wheels if necessary

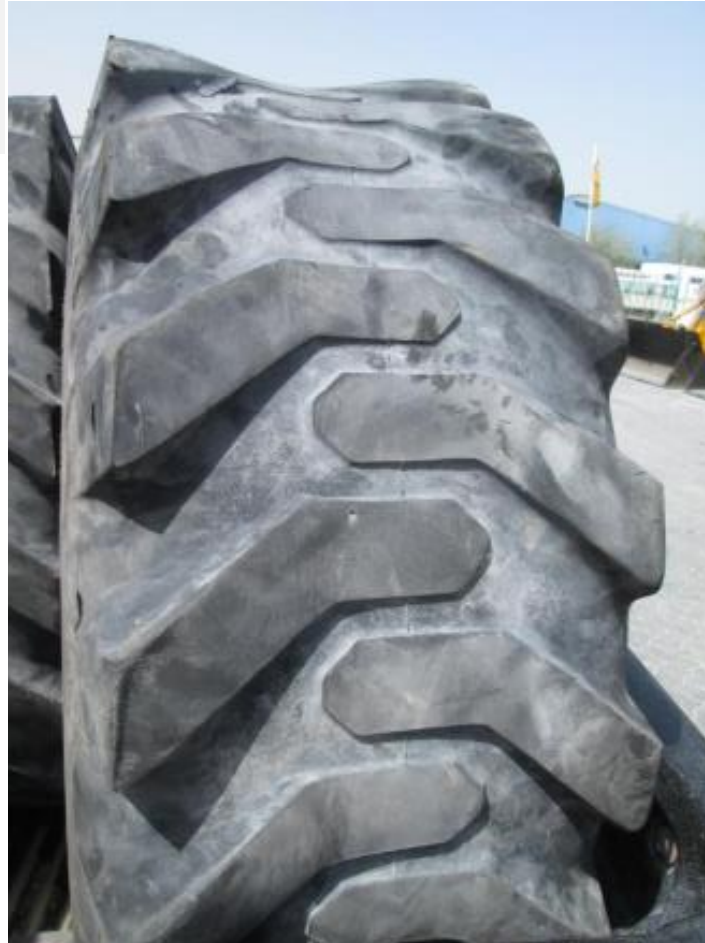
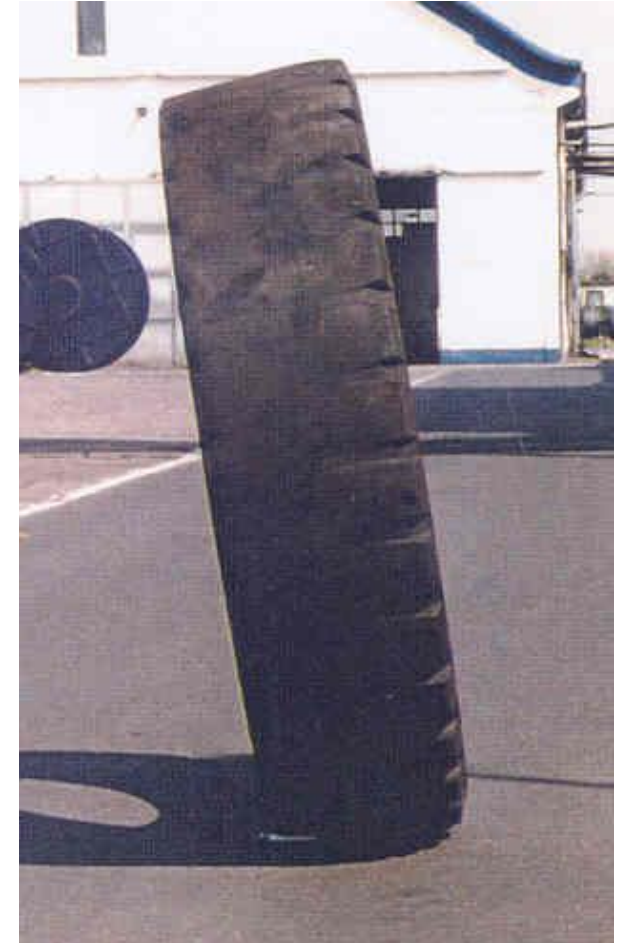
E06: ABNORMAL FAST WEAR

Worn tire

- Compound
- Application

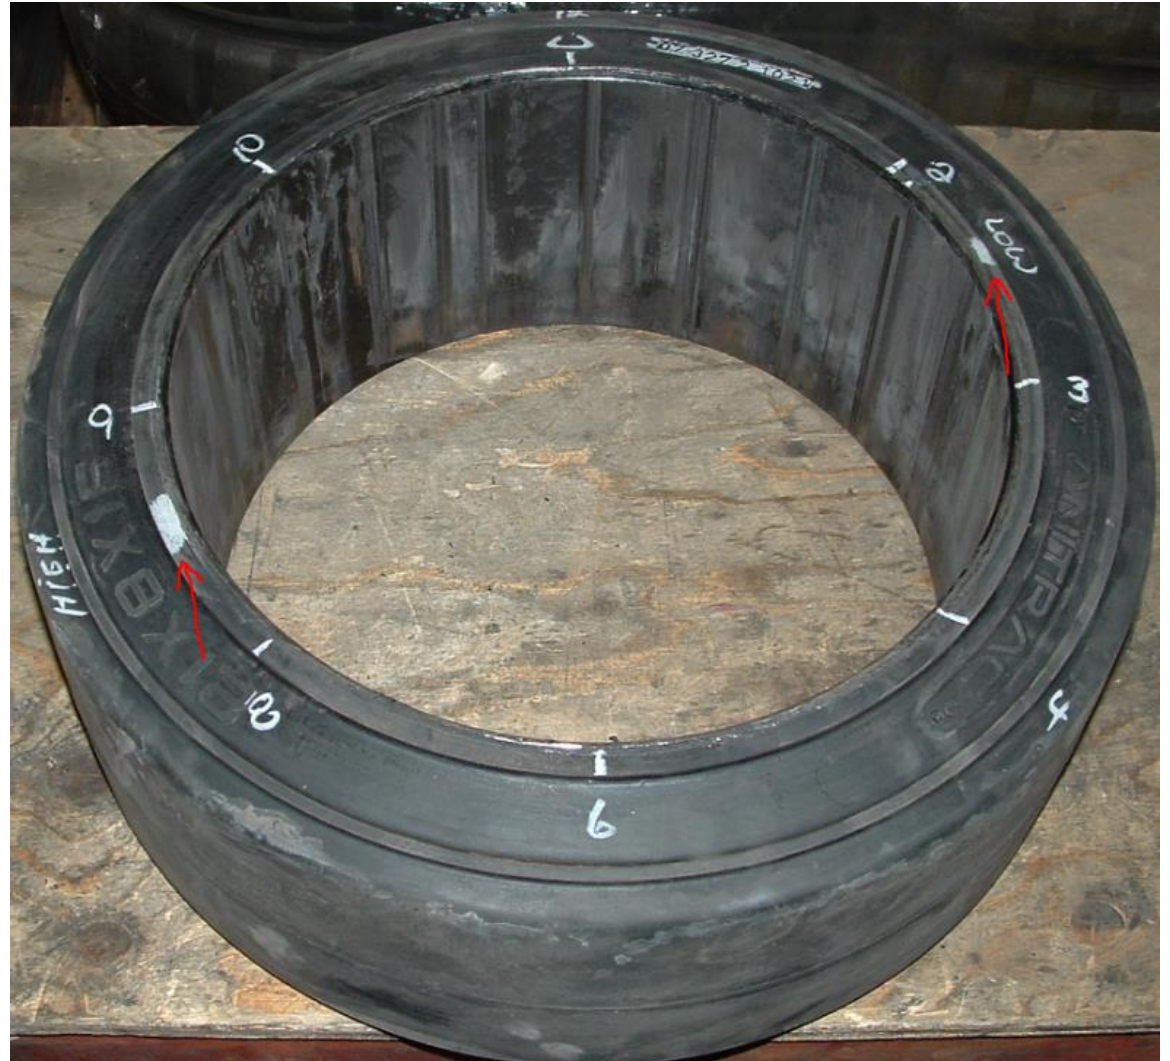
E09: SOFT OR DISCOLOURED SPOT (BLISTER)

Tread splitting (middle layer compound peeking through tread after short time or use on solid tires)
Blisters and soft spots on pneumatic tires

- Excessive rubber in middle layer at tire building process
- Hot spot in mold, or mold release contamination

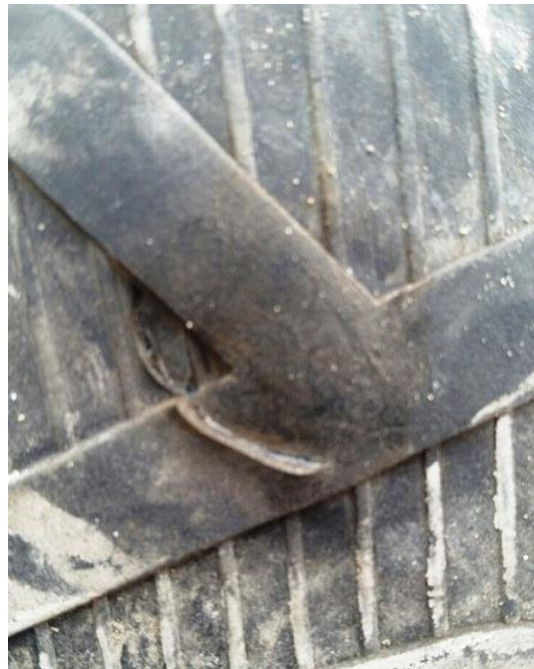
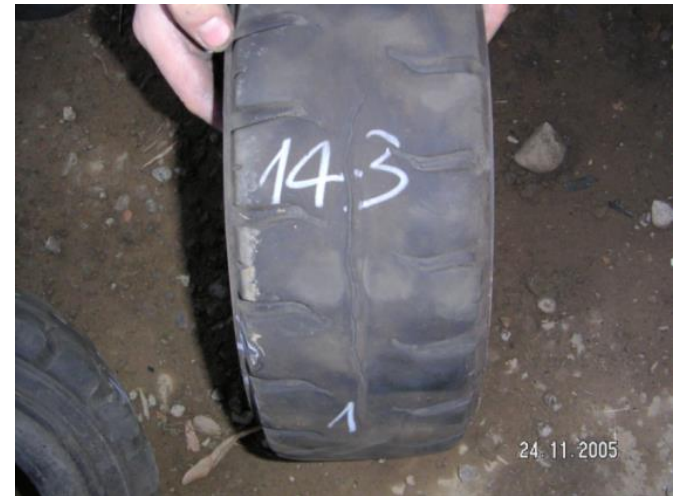
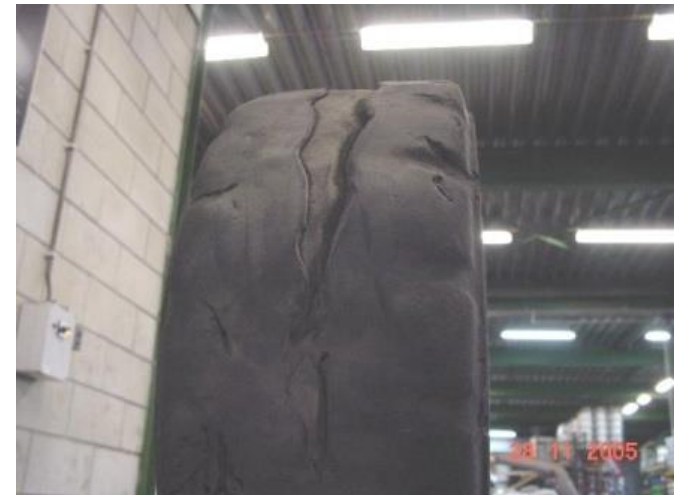
E10: FLASH CRACKING

The flash starts to separate after only a few hours of use

- Mold release agent trapped between flash

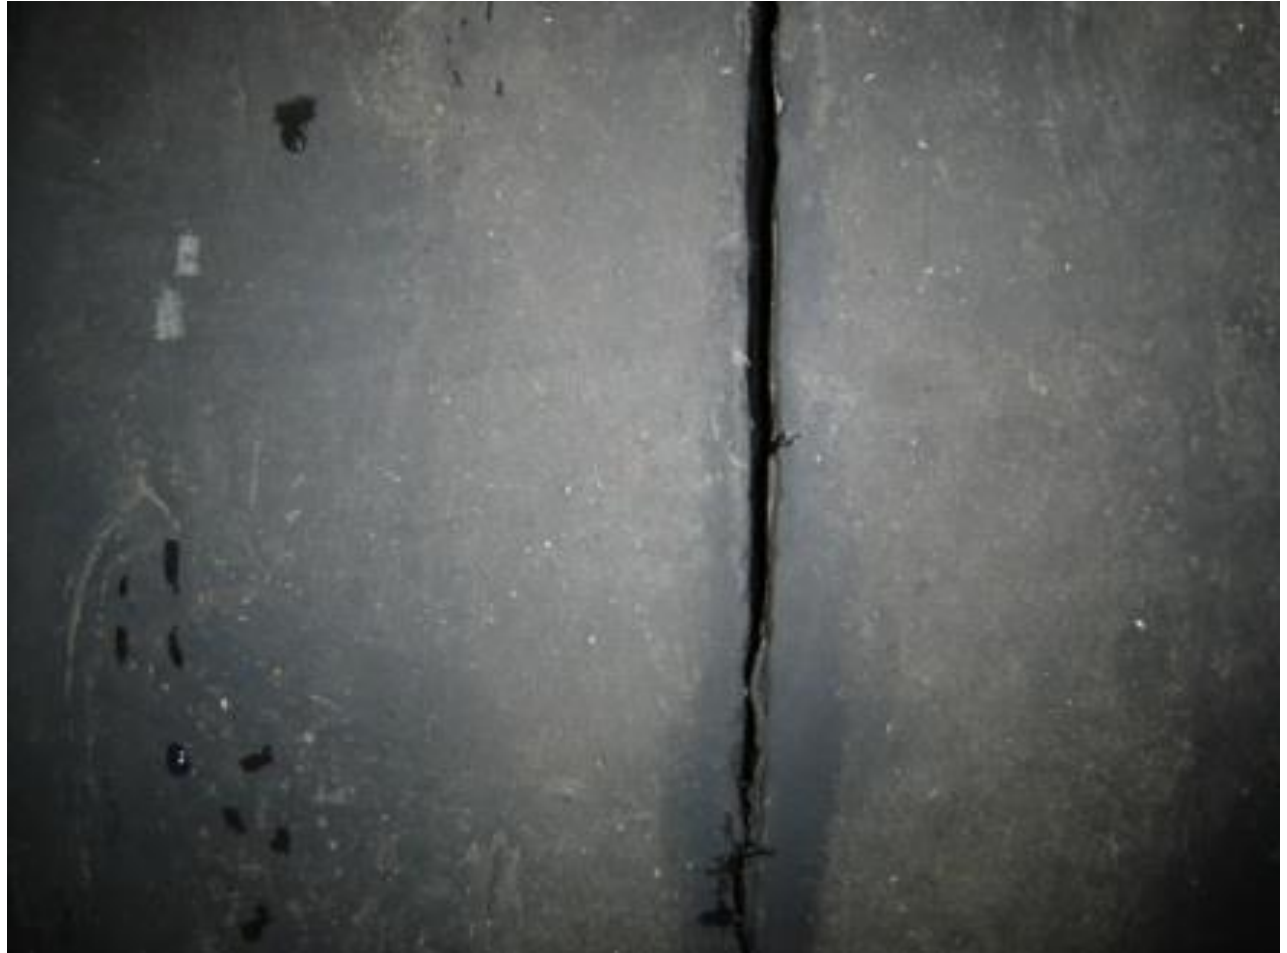
E11: RADIAL CRACKS

Radial cracks

- Overload

- Check axle loads for both loaded and empty conditions
- Check if the truck has been equipped with extra weight or special attachments
- Reduce the carried load, if possible
- Note: steer tire overload occurs when a truck is carrying loads that are significantly less than what it is rated to carry
- Use proper tire size (larger, wider), or use a “high load” compound
- Possibility to use larger equipment?

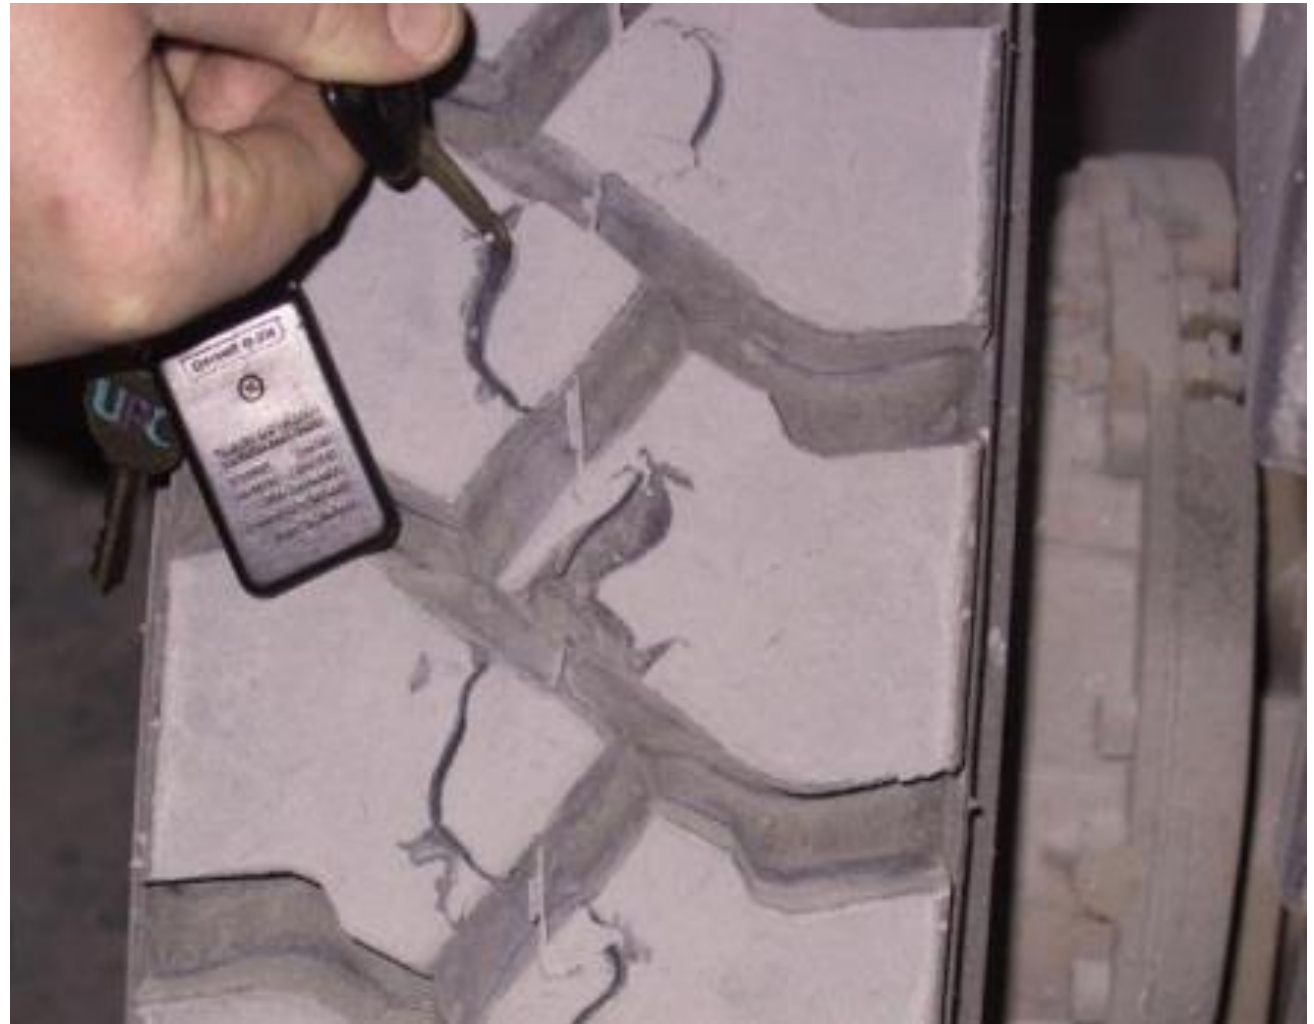
E14: TREAD DELAMINATION

Tread peeling off in layers

- Delamination (preure) between tread rubber layers due to too high temperature at tread rolling

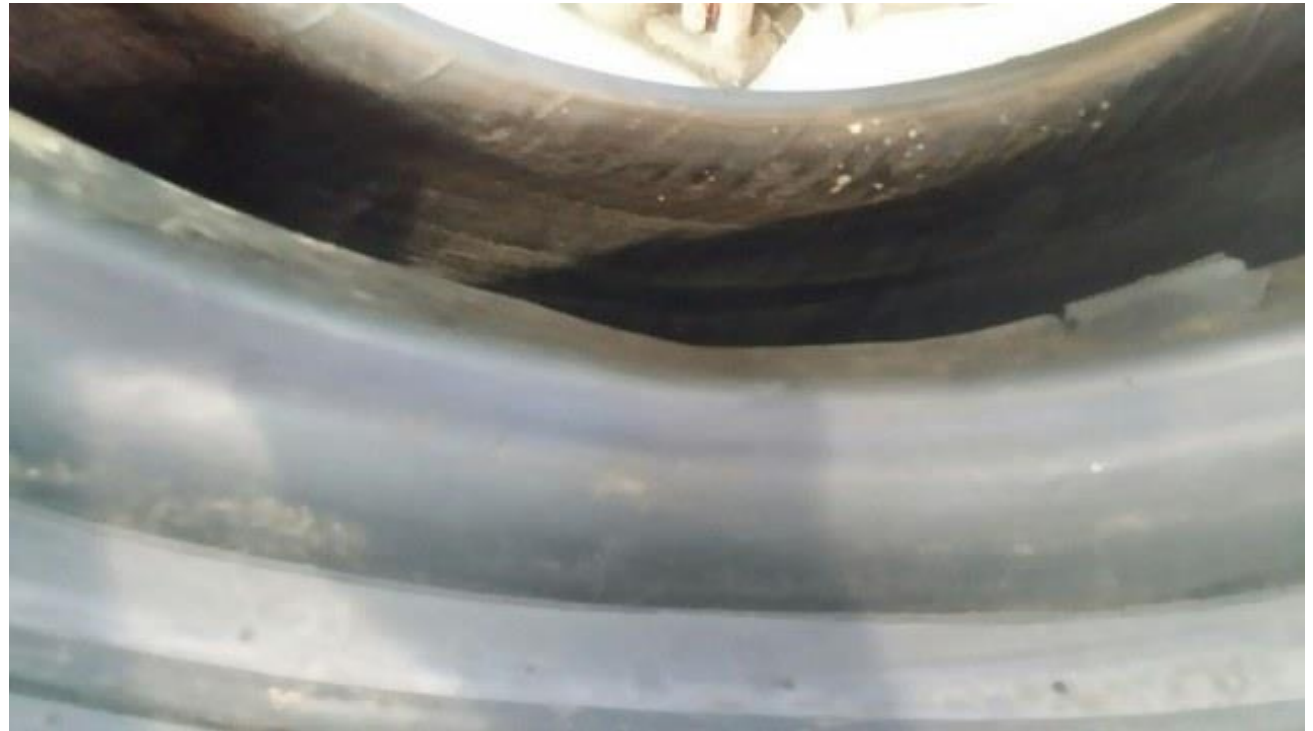
H09: VIBRATIONS

There may not be any visual indication of a vibration issue

- Flat spots or inconsistencies on the tread face

- Educate operator about flat spotting tires

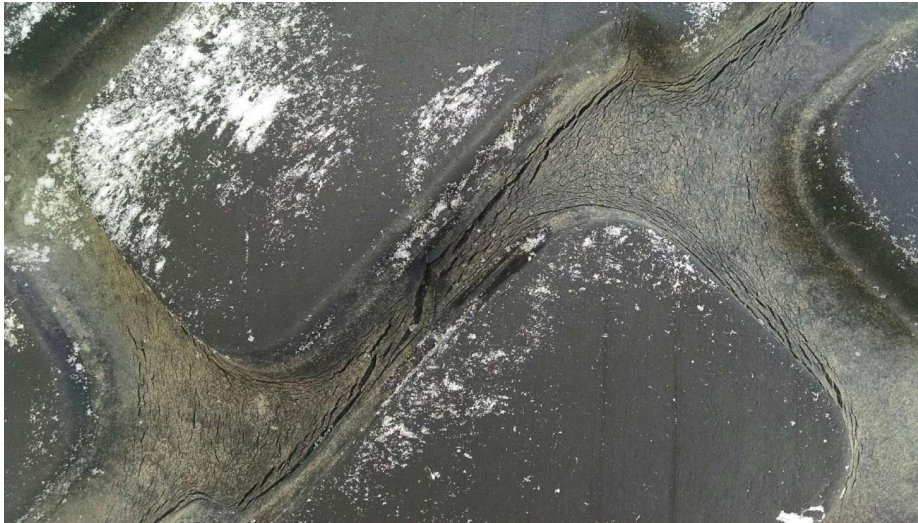
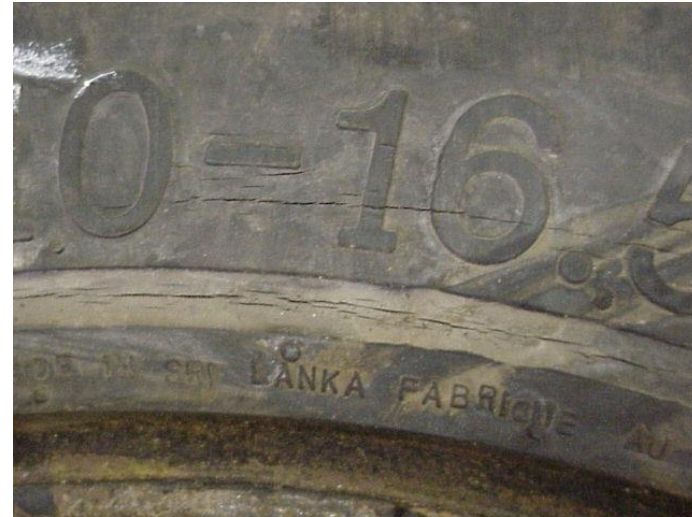
H10: WEATHER CHECKING

Small cracks at sidewalls or between the lugs

- To long exposed to sun light and/or ozone

- Store tires in a protected environment: dark and dry place, away from ozone. If equipment is idle for long periods, place it on blocks, cover the tires with a dark covering and reduce the internal air pressure
