SERVICE CONDITIONS AND WARRANTY GUIDELINES

AGRICULTURAL TRACK

Including Drive Wheels, Idlers, Midrollers

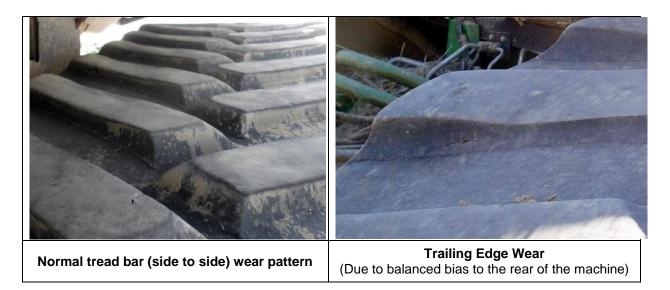
Tread wear rate <u>increases</u> significantly during roading operations. It is important to minimize the distance and duration of high speed roading whenever possible. If long distances must be covered, consider transporting rather than roading. If roading must be done, tread bar wear rates can be reduced by staying off pavement, reducing transport weight and speed, and adjusting machine balance for even <u>weight distribution</u> front to back. The greatest rate of tread wear occurs on a hot day with a poorly balanced, heavy machine. If possible, transport during cooler parts of the day and at reduced travel speeds and with minimum ballasted weight, as this will lower temperatures of the treads, guide lugs, and rolling components.

Transport during the track break-in period (1st season) above 10 mph should be avoided. Transport speeds and duration, if required during this time, should be well below posted limits as track damage is much more likely during the break-in period

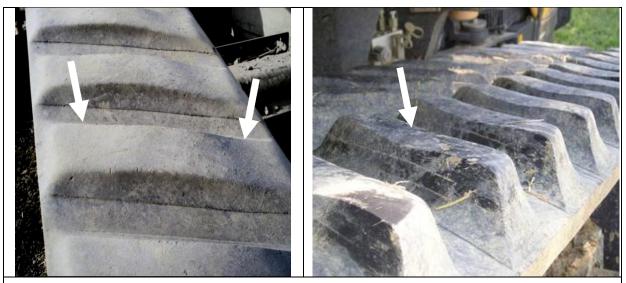
Typical Wheel path Wear (Narrow and wide tracks)

Tread bars will also wear at different rates across the track width. This is because the area with the highest wear rate is under the highest load – this highly loaded area of the track is called the <u>wheel path</u>. It is normal for the inboard side of the track to wear faster than the outboard side, due to axle deflections, curvature of the road surface, etc... Tread bars will also wear faster on one side of the machine if always turned the same direction during field operation. If turning occurs frequently in only one direction, rotating tracks seasonally will even out tread wear.

Wear rate is increased by high slip and high vertical loads. Operation with wider tracks and wide wheel packages (if available) will lower wear rates and also lower temperatures during roading or transport. Because of this, always operate with the widest tracks available, and appropriate for the application. Uneven tread wear caused by using narrow midrollers with wide tracks may also cause higher vibration levels and flex damage to the carcass, so always use the widest midrollers available for the track.

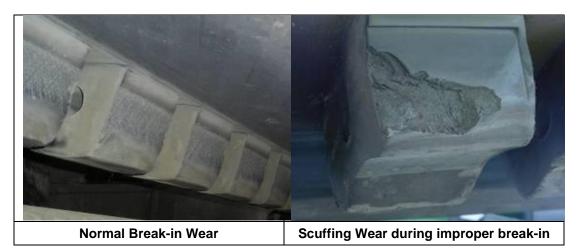
Extended roading of a new track during the break-in period and especially prior to initial field use, even with correct alignment, is <u>not recommended</u>, and may lead to <u>significant drive lug</u> <u>scuffing</u> as well as midroller failures due to heat. <u>Break-in wear is non-warrantable</u>.

If damage is seen on both sides of the guide lug, it is usually caused by "**break-in**". If damage is seen only on one side of the guide lug, it is usually caused by **misalignment**.

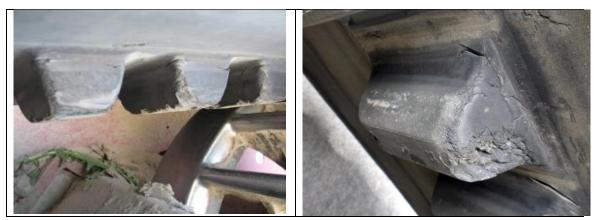
Typical Drive Lug Break-in Wear

Typically, wear will be seen on the edges of the lugs and small cracks can develop at the corners of the lug as shown in the attached pictures. This condition is considered normal and not an indicator of drive lug overall life. The types of drive lug wear can vary depending on conditions and applications. Regardless of appearance, drive lugs are considered serviceable if more than 50% of the lug remains attached. If one drive lug is missing, the track can also remain in service but overall life will likely be reduced as loads will increase on the surrounding drive lugs.

Typical Drive Lug Mid-Life Wear

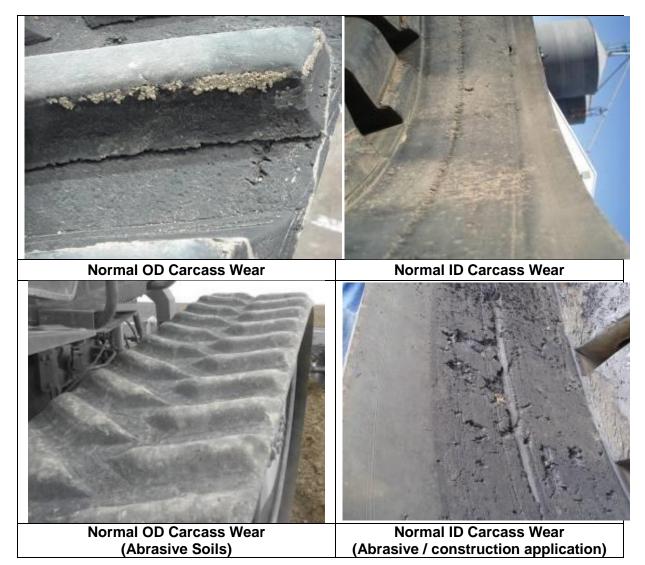
6.1 Typical Wear Patterns / Characteristics

Carcass wear can vary depending on the environment and the application. During track operation, many surface blemishes can appear on the outside and inside carcass surfaces, including; cuts, scrapes, scratches, nicks, surface cracks, slits, etc. In cases where sharp objects are contacted, then varied degrees of minor carcass damage can result. These types of cuts and marks are a normal result of operation in the fields.

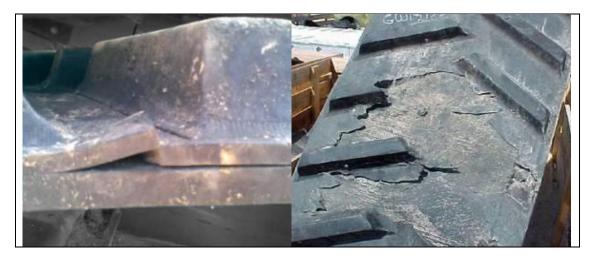
6.2.1 Carcass Separation (Traction Lug Side)

Major Separation

WARRANTY CAUSE: Contamination or poor manufacturing cure.

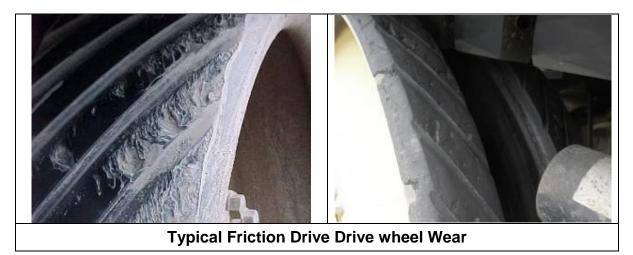
Friction Drive Drive Wheels

Drive wheel tractive effort on a friction drive system relies on the drive wheel rubber grove edges to wipe mud and moisture out of the track. Anytime the groove leading edge is damaged or rounded, or if proper track tension is not maintained, the effectiveness of the drive wheel at "grabbing" the track is diminished and internal slip can occur.

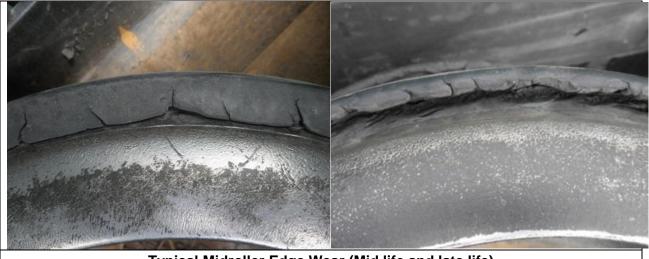
Typical Midroller Edge Wear (Mid life and late life)

- Total load (narrower midroller have higher unit loading)
- Extent of abrasive conditions causing physical damage
- Peak temperatures seen during operation and extended roading, or from misalignment
- Material cascading into track system

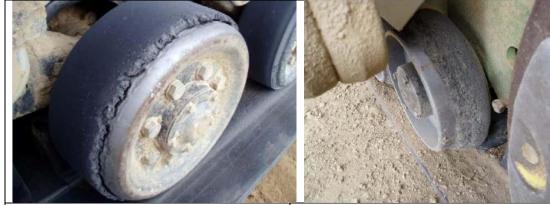
Outer edge wear and missing coating is common on midrollers and do not require replacement unless they meet one of the above criteria.

Less than 1/3 of coating is missing Midroller can continue to run.

More than 1/3 of the total coating is missing Midroller should be replaced.

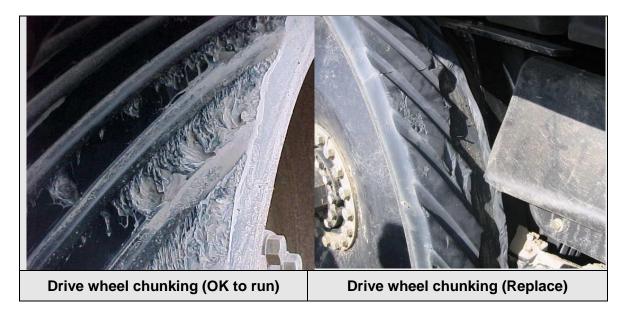
9.3.3 Pitting or Chunking (Drive wheels)

MAJOR PITTING

WARRANTY CAUSE: Poor manufacturing / process control

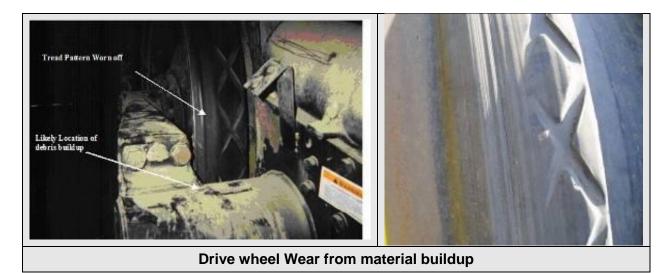
9.4.1 Grinding or Polishing Wear

NON-WARRANTY CAUSE:

- Buildup of material/debris on the track system or roller frame
- Low track tension causing buildup on the wheels

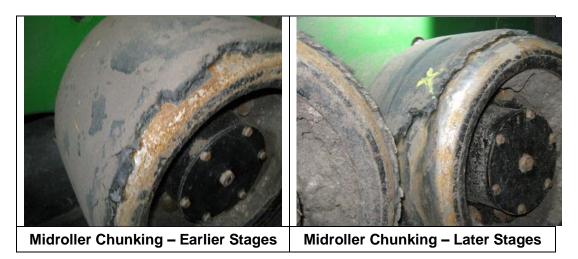
9.4.4 Outboard Edge Wear (Midrollers)

NON-WARRANTY CAUSE:

- Normal Wear
- High localized loads
- Abrasive, flint, or rocky soils
- Operation in narrow beds (material cascading into track system)
