PRODUCT FAILURE ANALYSIS

TIRES AND WHEELS

Issue date: September 1, 2015 V8

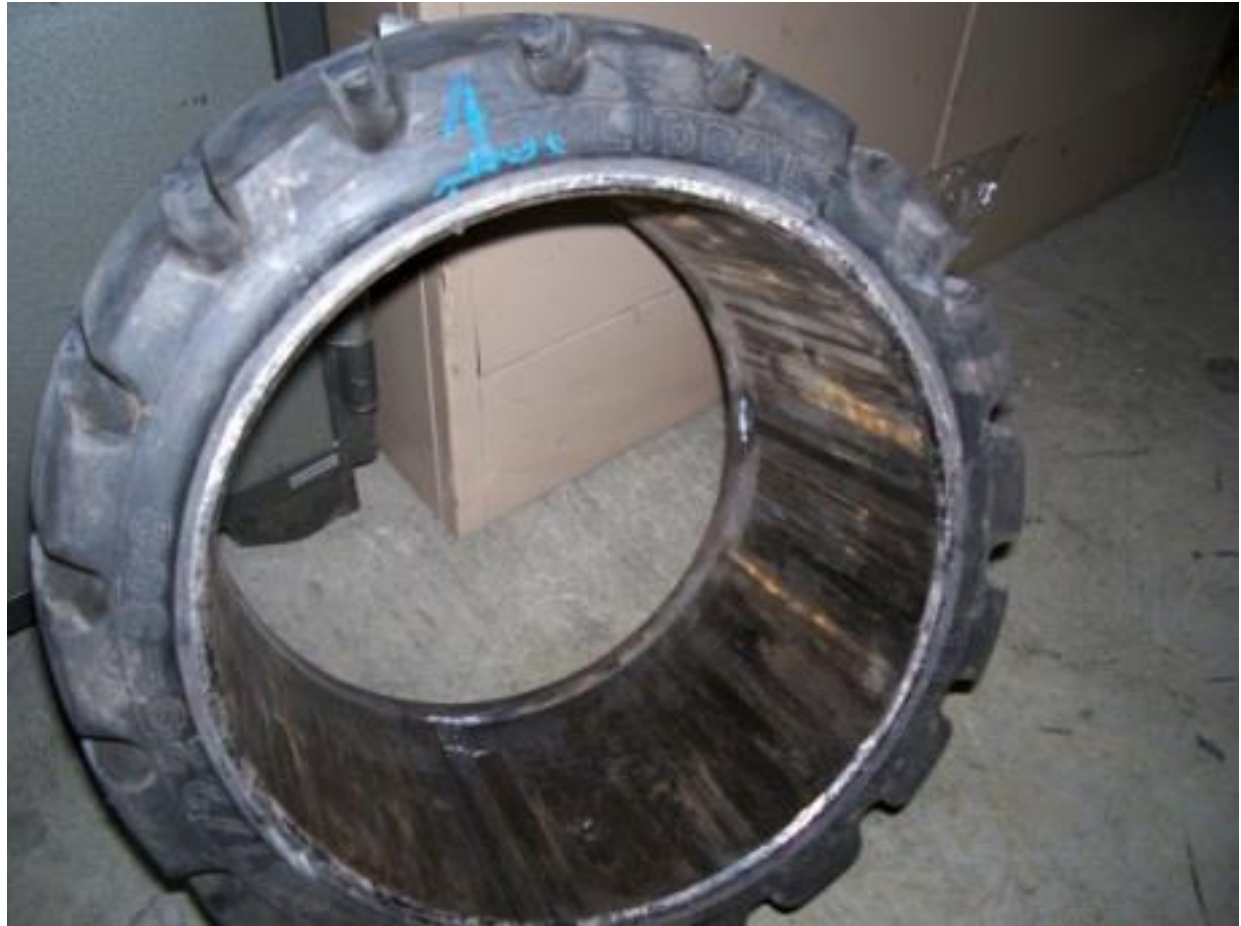
A04: STEELBAND SIZE TOO SMALL

Damaged steelband

- Steelband too small
- Bad mounting
- Rim deformed/damaged
- Rim too big

- Check if tire size is the correct for the wheel
- Check rim for deformation and damages

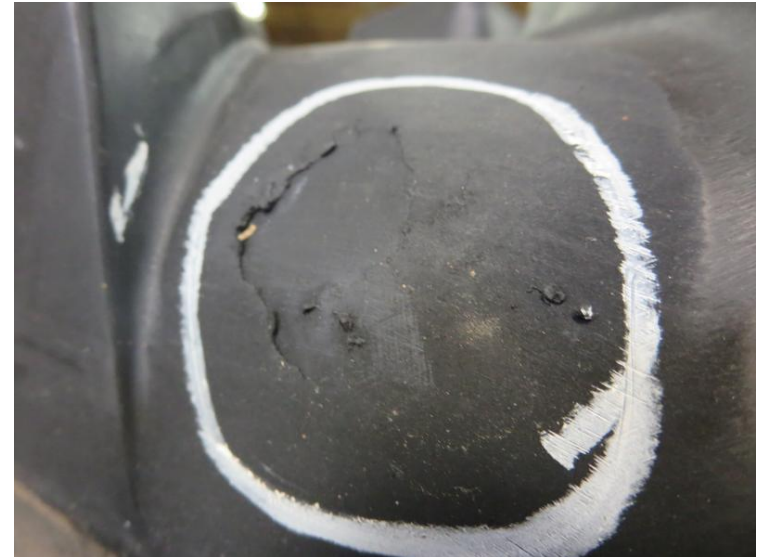
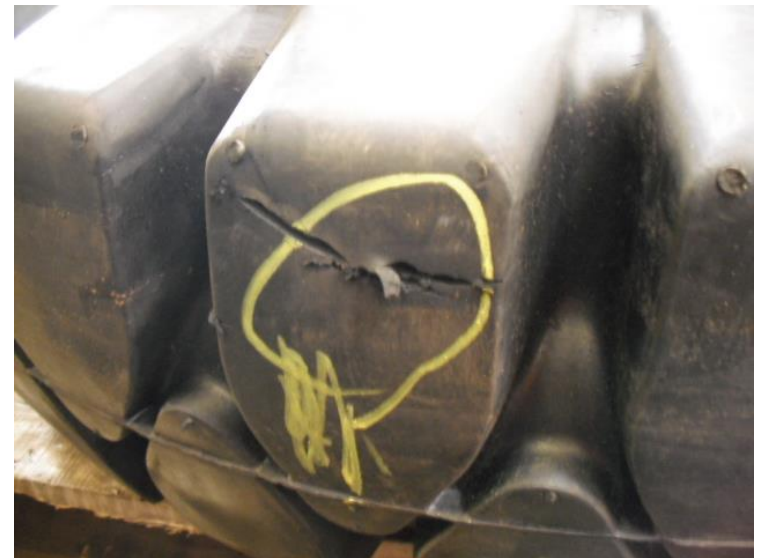
B01: PAINT (COLOUR, GLOSS...)

The performance and lifetime of the product will not be affected

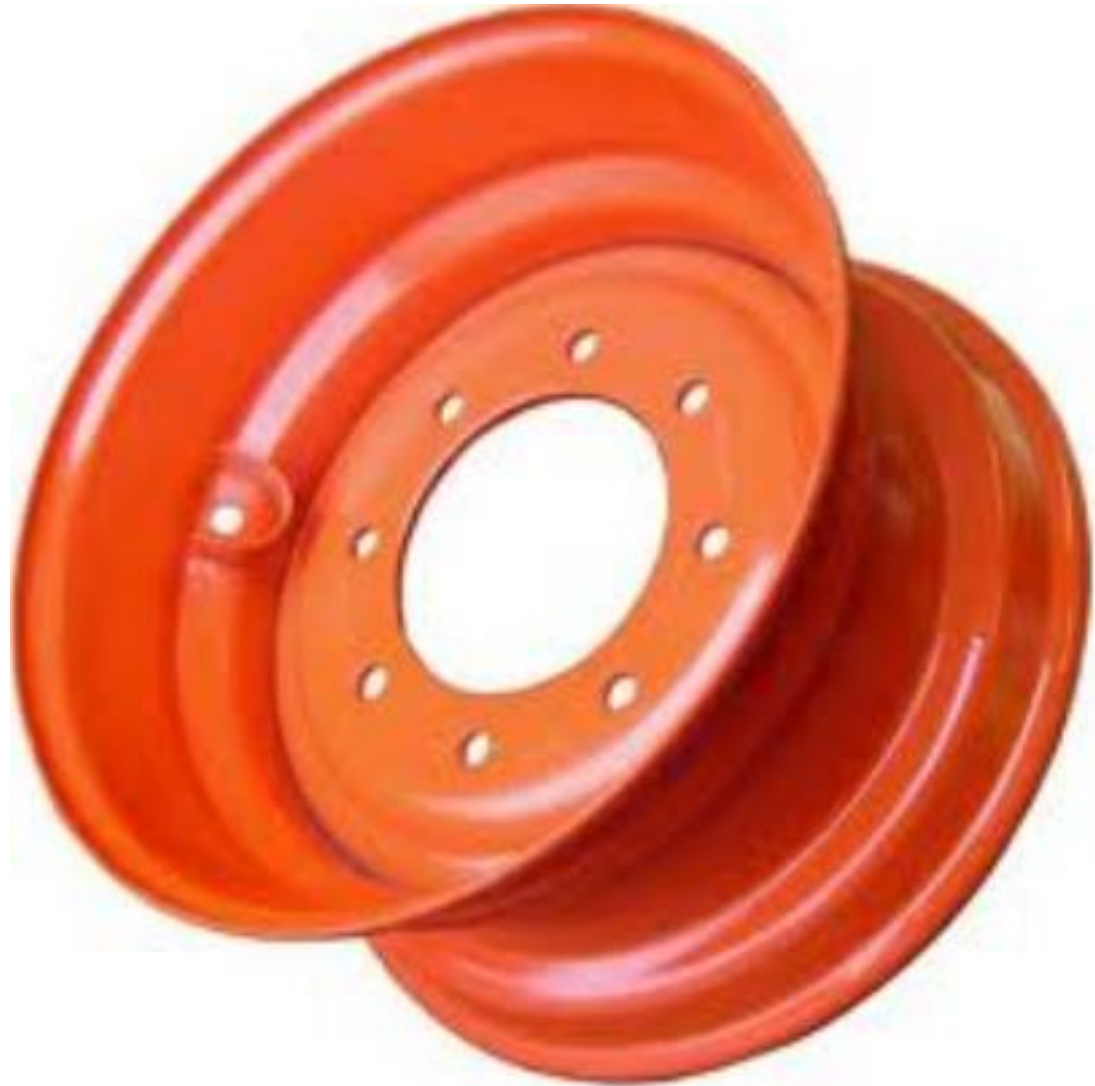
B02: PAINT PEELING OFF

The performance and lifetime of the product will not be affected

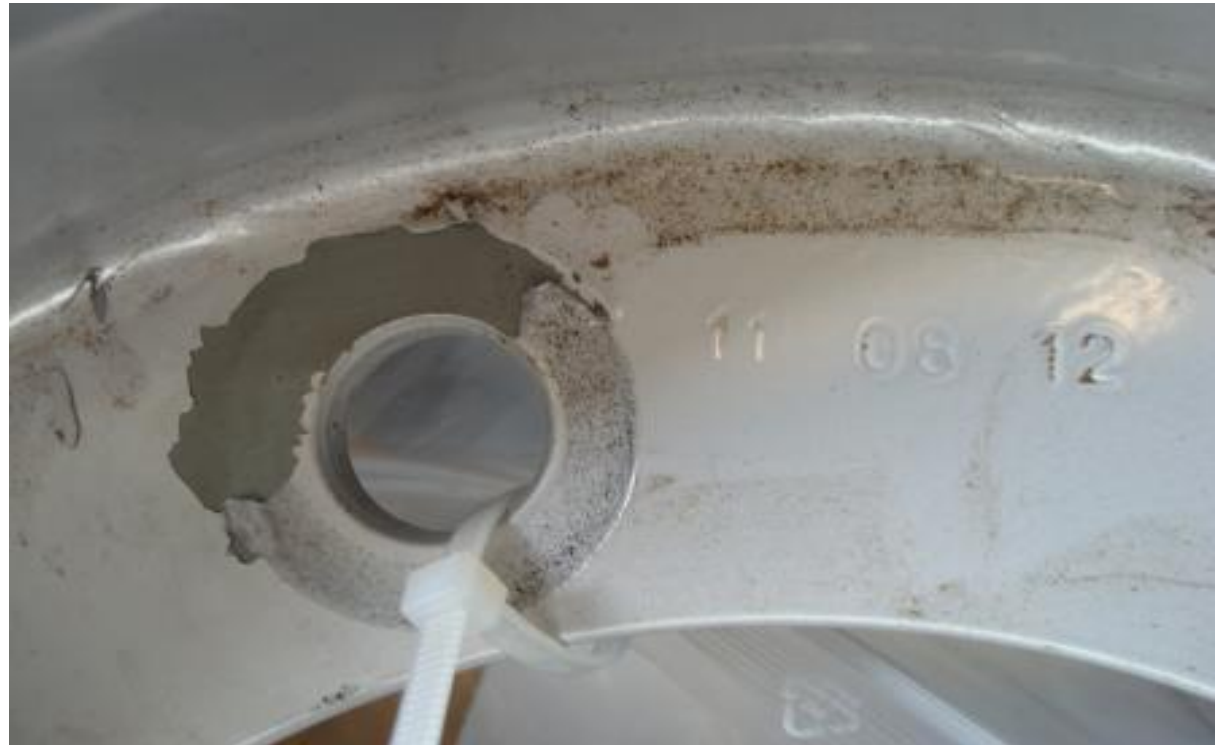
B03: WELD OF RIM/WHEEL/NAVE PLATE

Weld inconsistent, not finished, gaps or burn through

Remove affected wheel from service

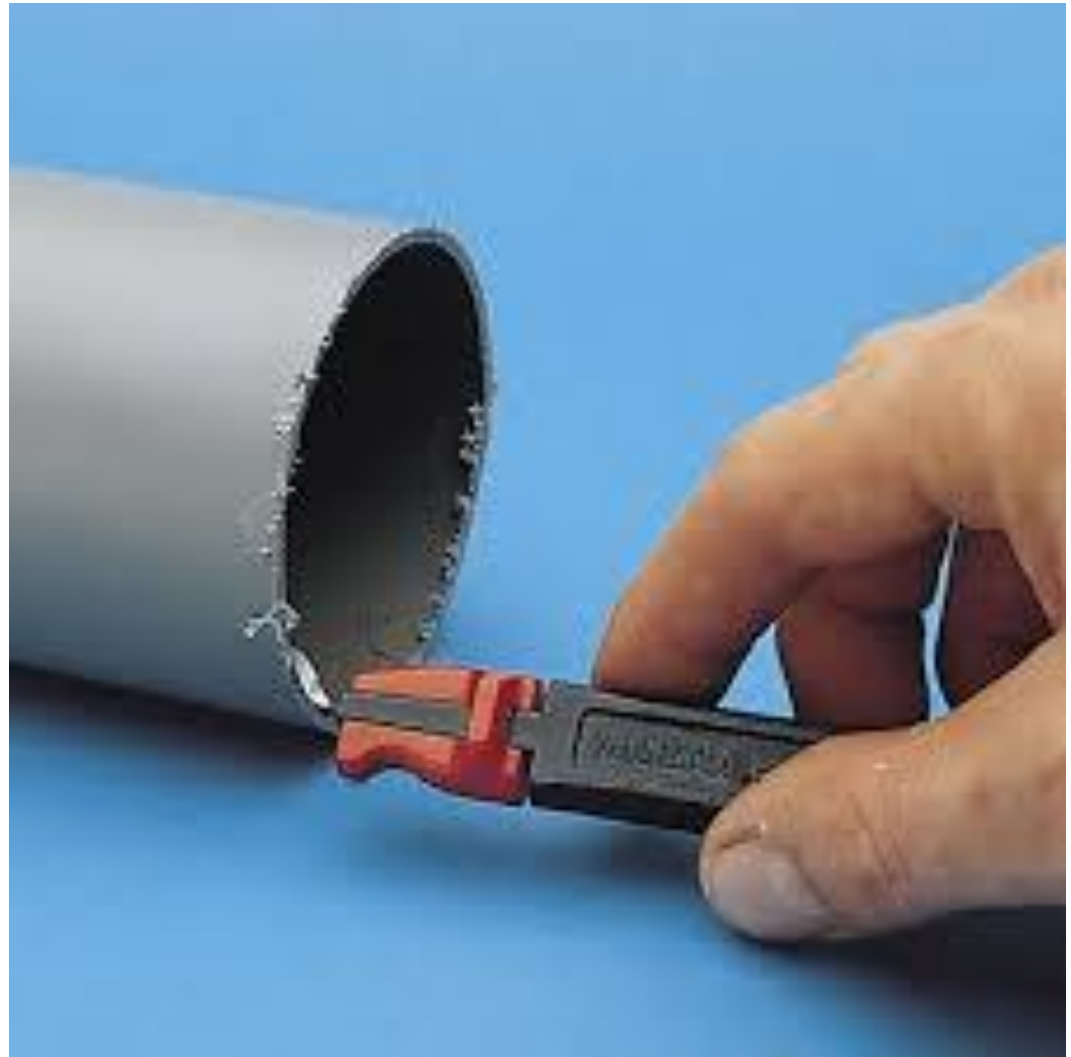
B05: STAMPED MARKINGS

Stamped markings are; incorrect for the product, not ledgeable or missing completely.

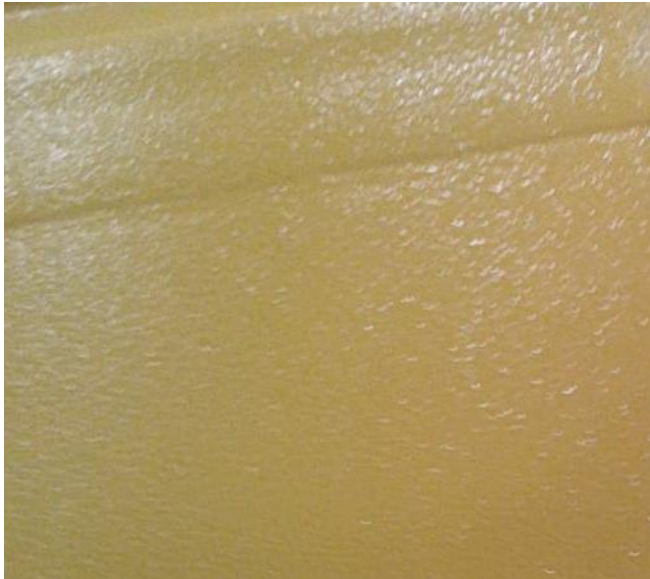
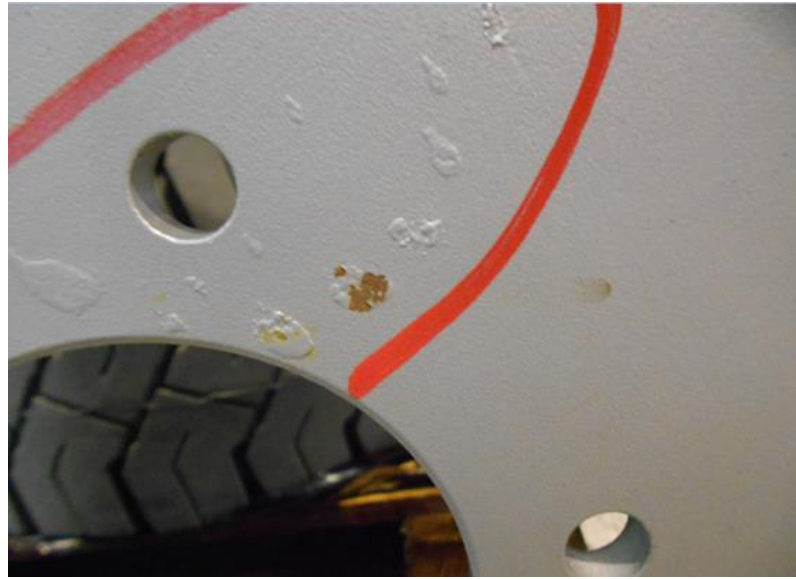
I11: PAINT THICKNESS

Paint appears too thick or too thin in coverage

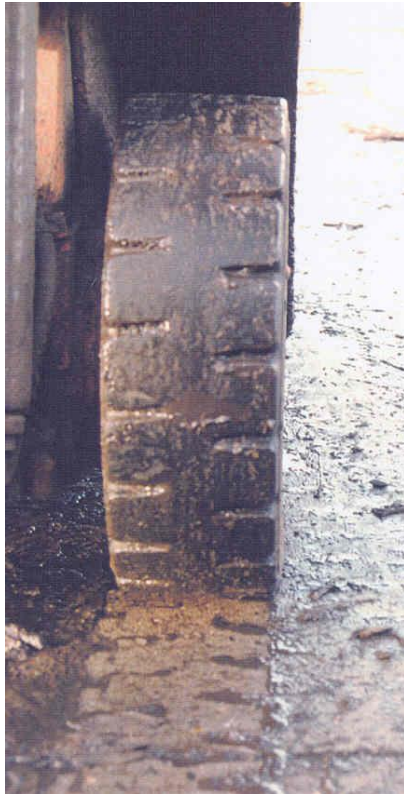
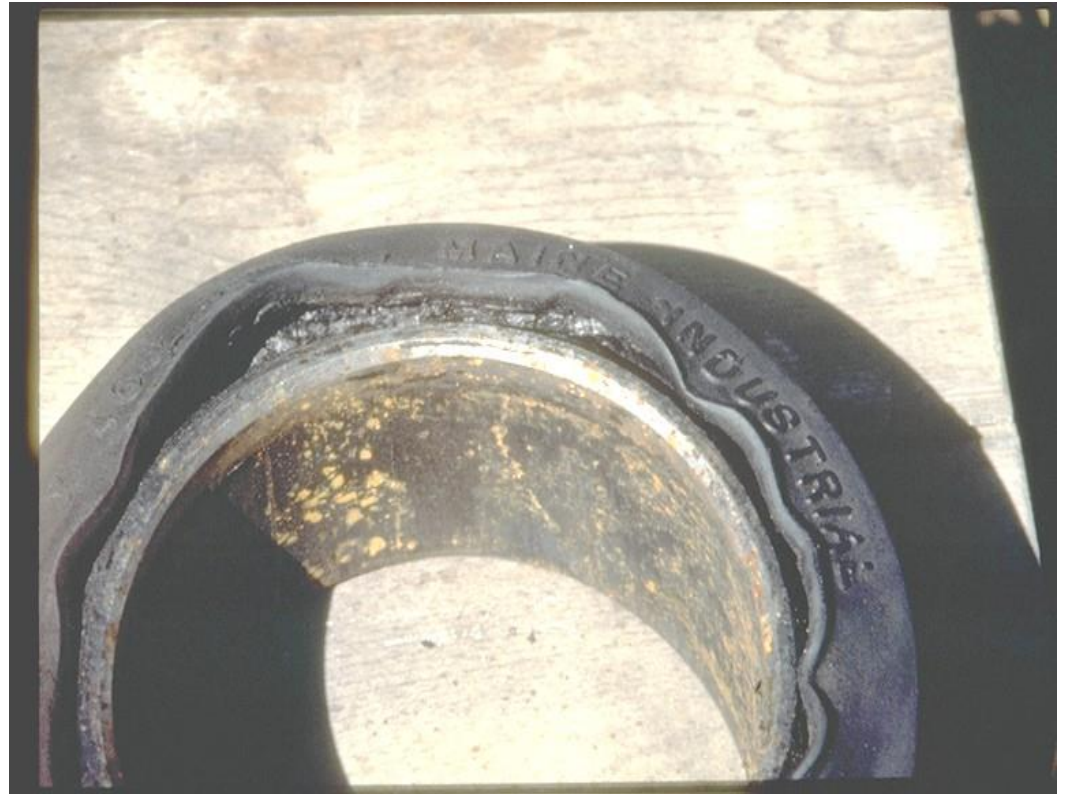
ENVIRONMENTAL CONDITIONS

- Solvents, Oils
- Cleaning Chemicals
- Steam
- Animal Fats
- Salt

**Good housekeeping
and floor maintenance
programs are a must!**

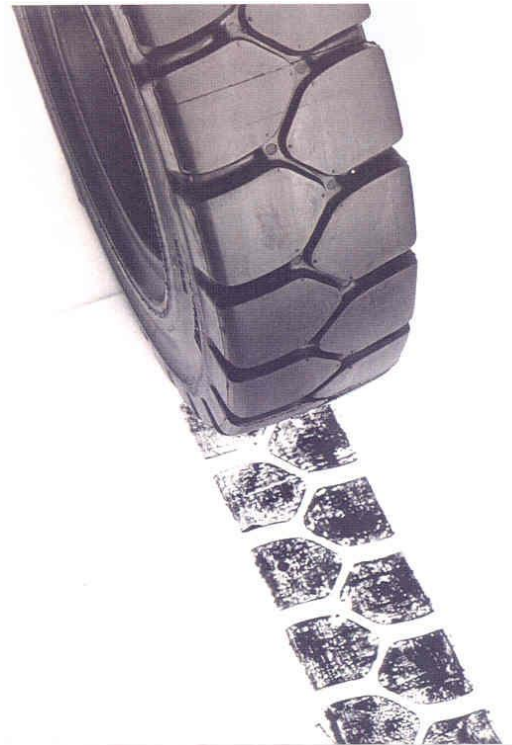
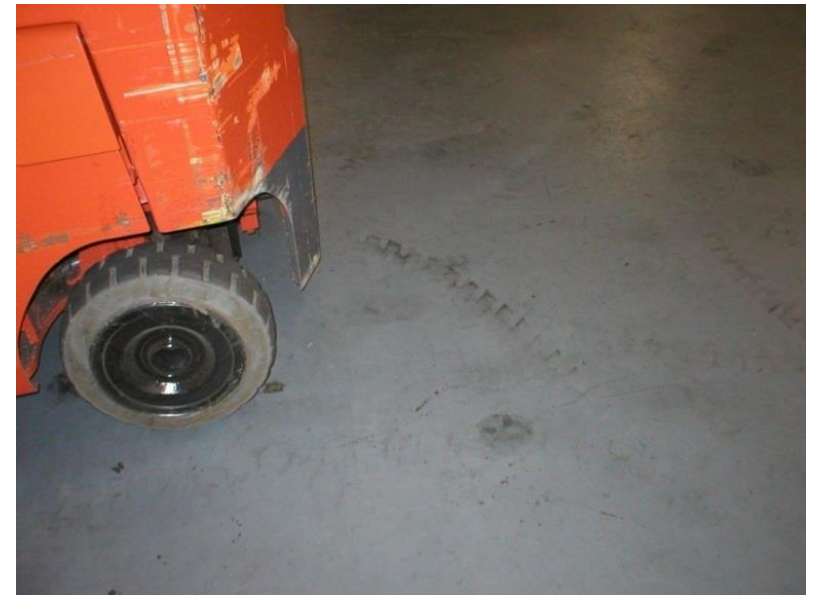
MARKING THE FLOOR

- Tires that contain carbon black can mark floors.
- Recommend non-marking tires and a static strap (or other method of discharging static electricity)
- Non-Marking tires will not mark the floor, but dirt that collects on them will
- Good housekeeping and floor maintenance programs are a MUST!

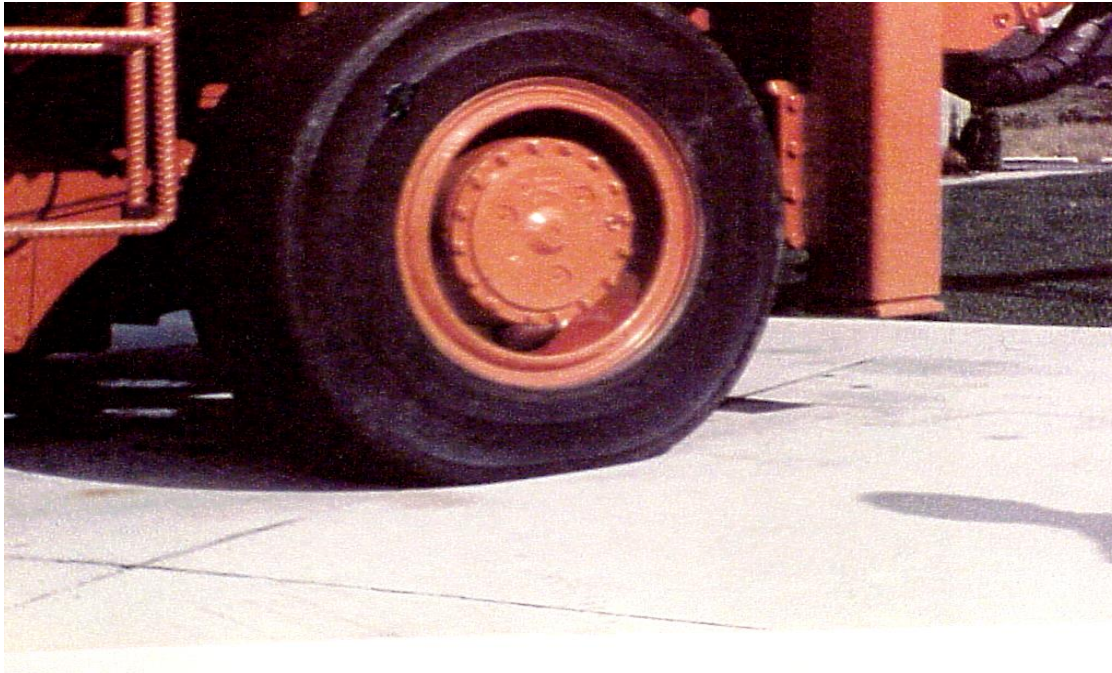
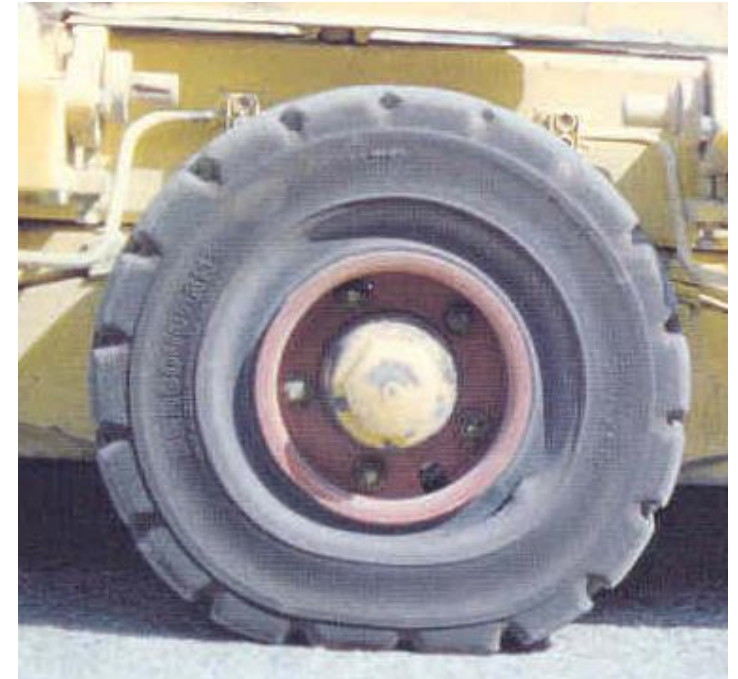
FLAT SPOTTING

- Occurs when a truck has been kept idle for a while
- The tire shows a flat spot, causing a vibration when starting to roll again
- Disappears when the tire has reached its normal running temperature
- Avoid/minimize stand still of trucks under load
- If there is repetitive bouncing on one tire only, it may be due to a manufacturing defect (porosity, bad distribution of rubber layers, etc.) or an “out of round” condition as a result of spinning the tires
- Flat spots may also be the result of skid-braking, hot shifting, and towing or dragging the machine
